SAN FRANCISCO BAY SUBTIDAL HABITAT GOALS REPORT

Appendix 6- I: Removal of Creosote-Treated Pilings and Structures from San Francisco Bay

Removal of Creosote-Treated Pilings and Structures from San Francisco Bay

December 10, 2010

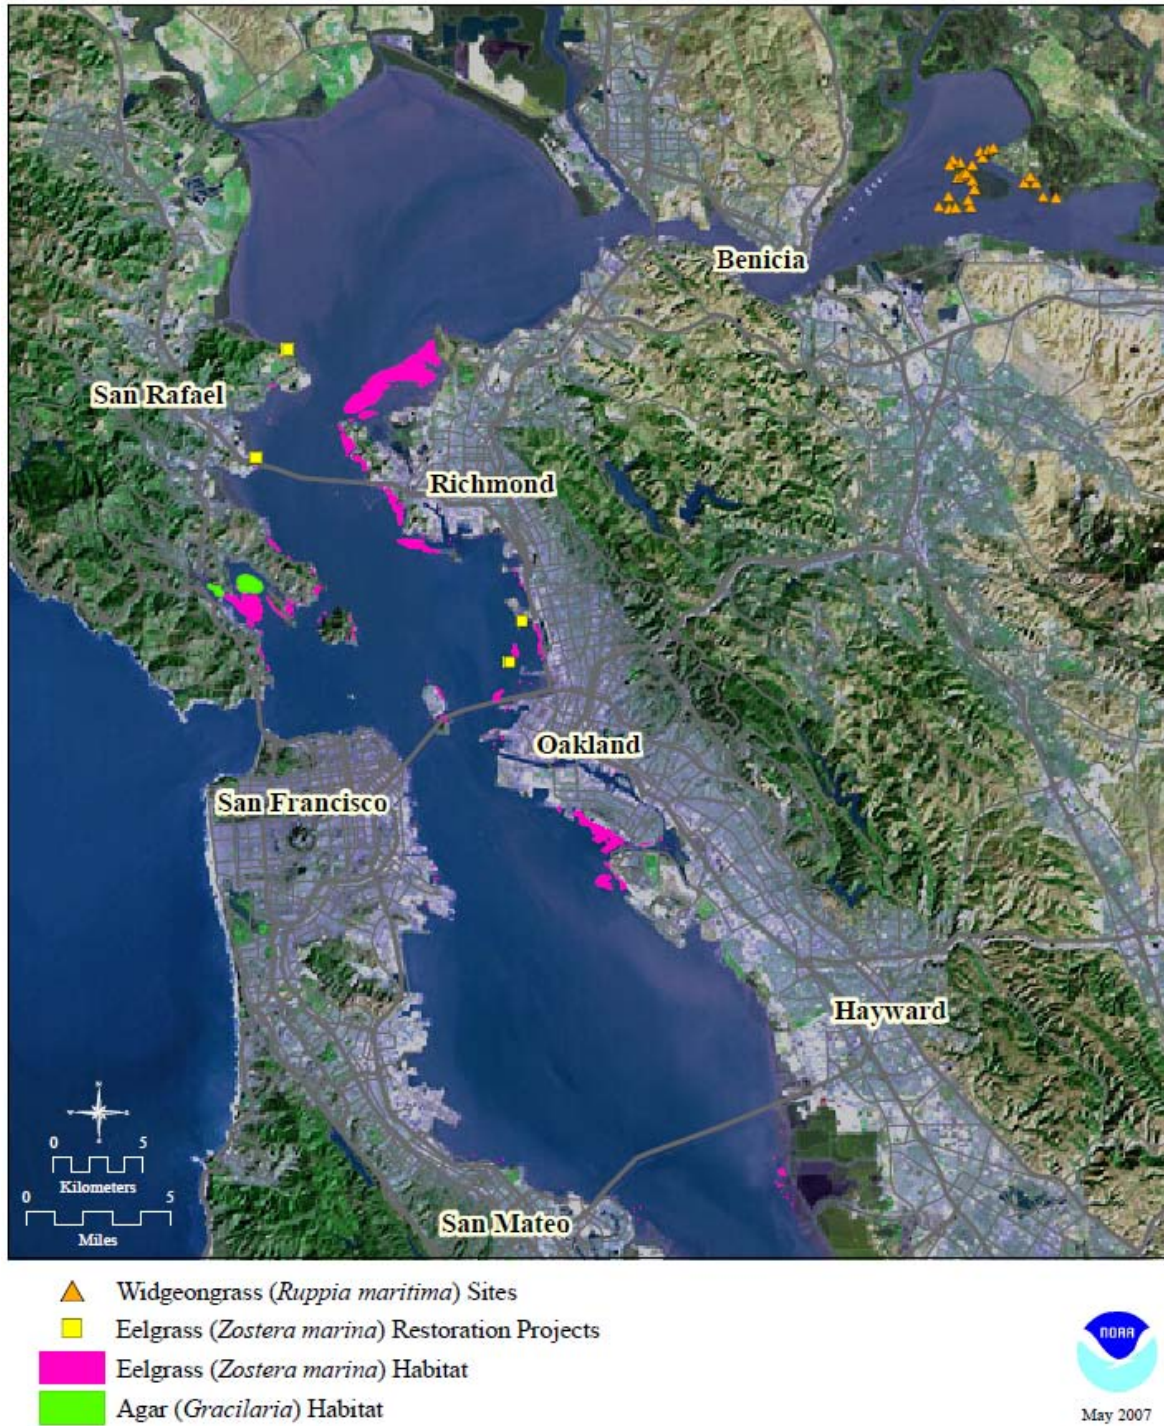
Figure 1-2. Distribution of eelgrass beds and other submerged aquatic vegetation in San Francisco Bay (From NOAA 2007).

- The report also separates out **subtidal plant beds**, including algal beds and SAV. Eelgrass beds are the most common SAV in San Francisco Bay (Figure 1-2). SAV species provide primary productivity and decrease erosion by dampening the effects of waves, decreasing sediment resuspension, and increasing deposition. SAV provides a hard surface for attachment of invertebrates and habitat for fishes. Eelgrass beds are favored sites for deposition of eggs by Pacific herring. Shading by artificial substrates is one of many stresses that may limit subtidal plant beds.

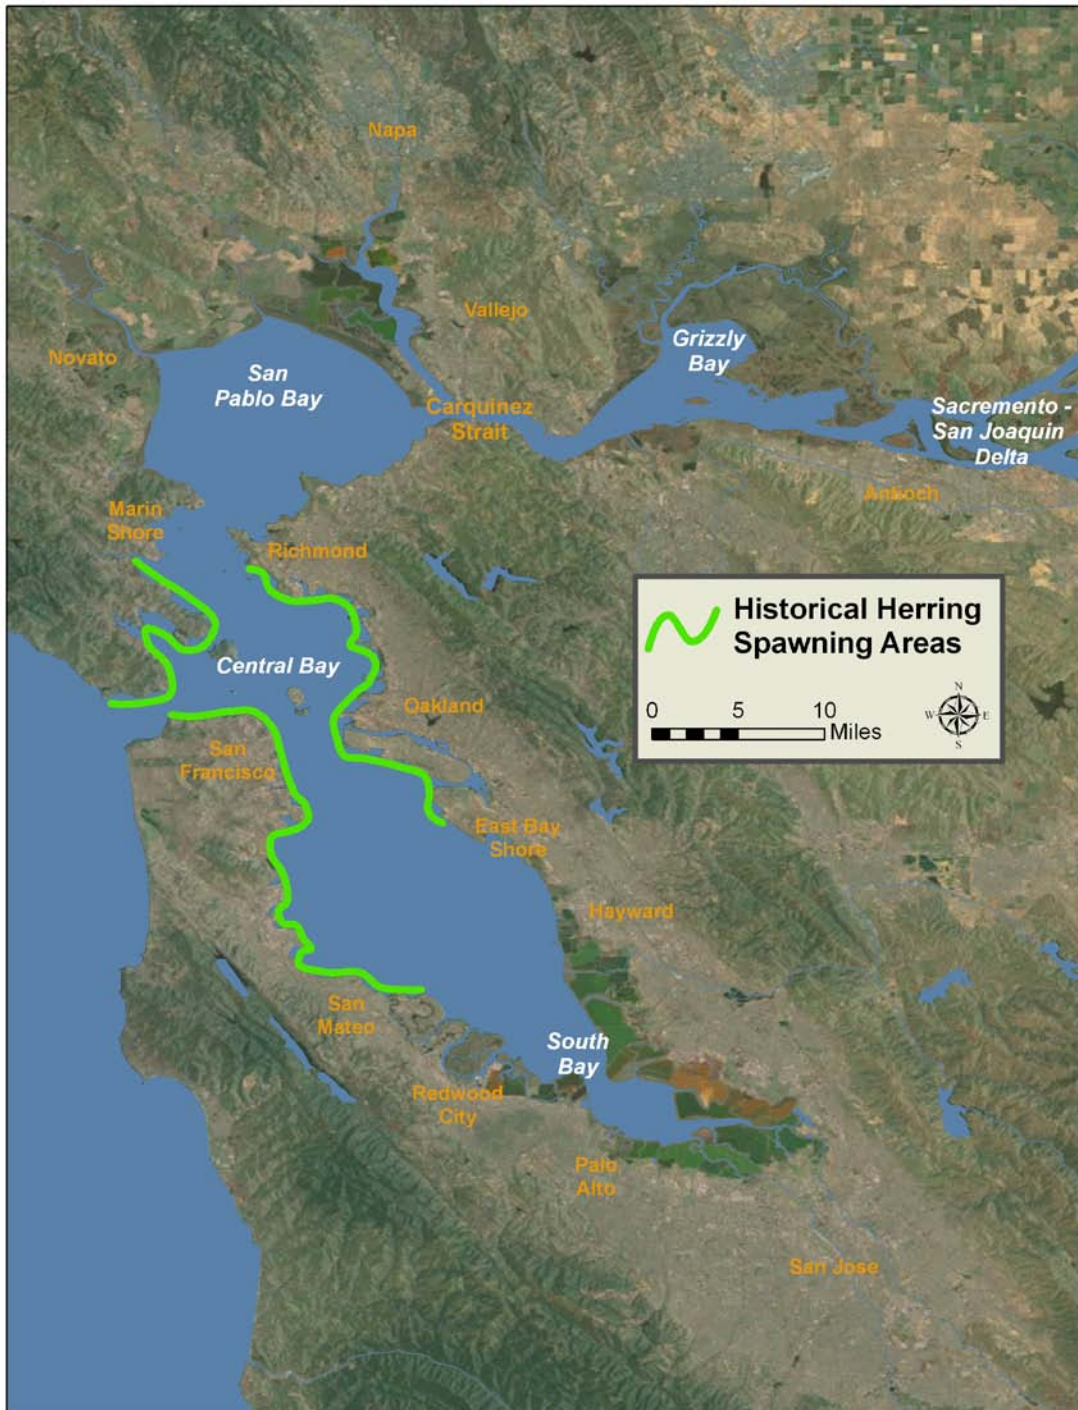
Figure 1-3. Historical herring spawning areas in San Francisco Bay.

Of the many fish species that inhabit San Francisco Bay, the Pacific herring is of special interest to this project, because they sometimes spawn on creosote-treated pilings. Pacific herring enter San Francisco Bay to spawn in the Central Bay and South Bay (Figure 1-3) during the winter months. Precise spawning timing and locations vary from

year-to-year, almost always including Richardson Bay, an embayment located on the Marin shore. Herring spawn on hard surfaces, including eelgrass, seaweed, rock, pier pilings, retaining walls, riprap, and boat bottoms. Significant spawning has been known to occur along the San Francisco waterfront (Watters et al. 2004).

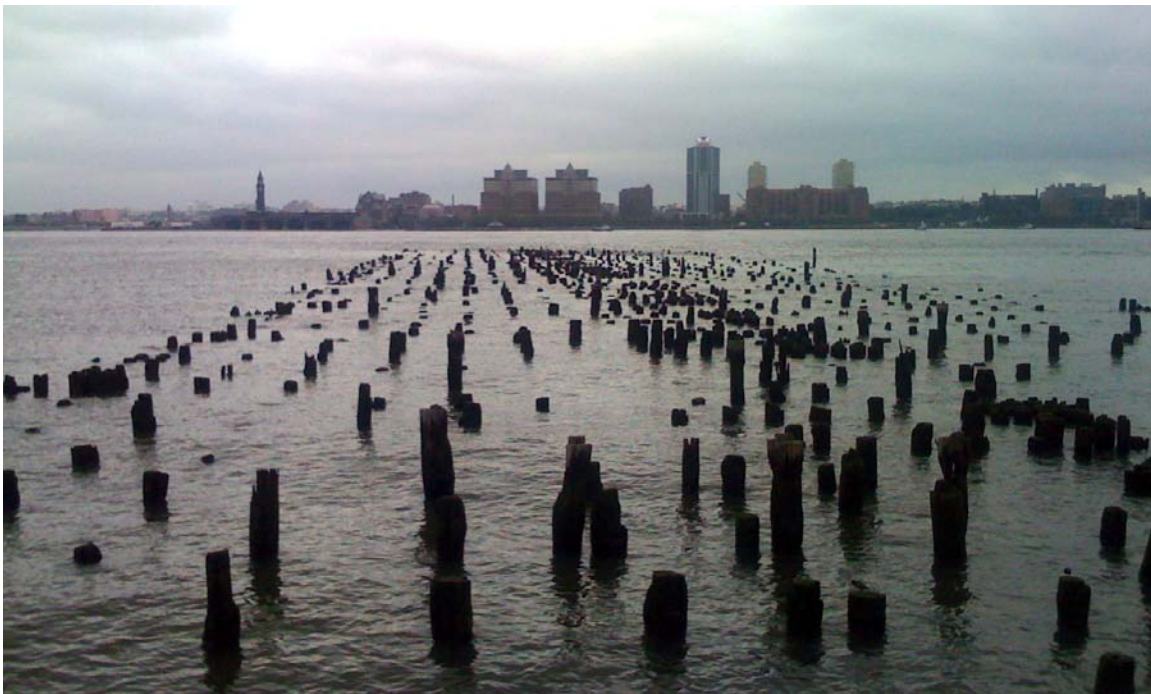
Figure 1-5. The Hudson River Park Trust removed decking but is committed to preservation of pilings as habitat for invertebrate and fish species. (project team photograph)

In some regions, piling are considered valuable habitat or aesthetically desirable features. In New York City's Hudson River Park, pilings have been preserved as habitat for invertebrate and fish species (Hudson River Park Trust 2009; Figure 1-5). Pilings are highlighted as platforms for sculptural art in another New York installation, the Hudson River Pilings Project. The artist has "long been enamored of the pilings; the submerged logs that once supported the Hudson's busy piers," showcasing the historical interest in waterfront structures (Benafiel 2009). At South Cove (Battery Park City) on the Hudson River, new piles were installed as part of a landscape art piece along the shoreline in late 1980s. In this case, the pilings were considered to be aesthetically pleasing. One of the collaborators described how they installed "pilings into the water to make a visual transition between the land and the water" (Jasch 2004).

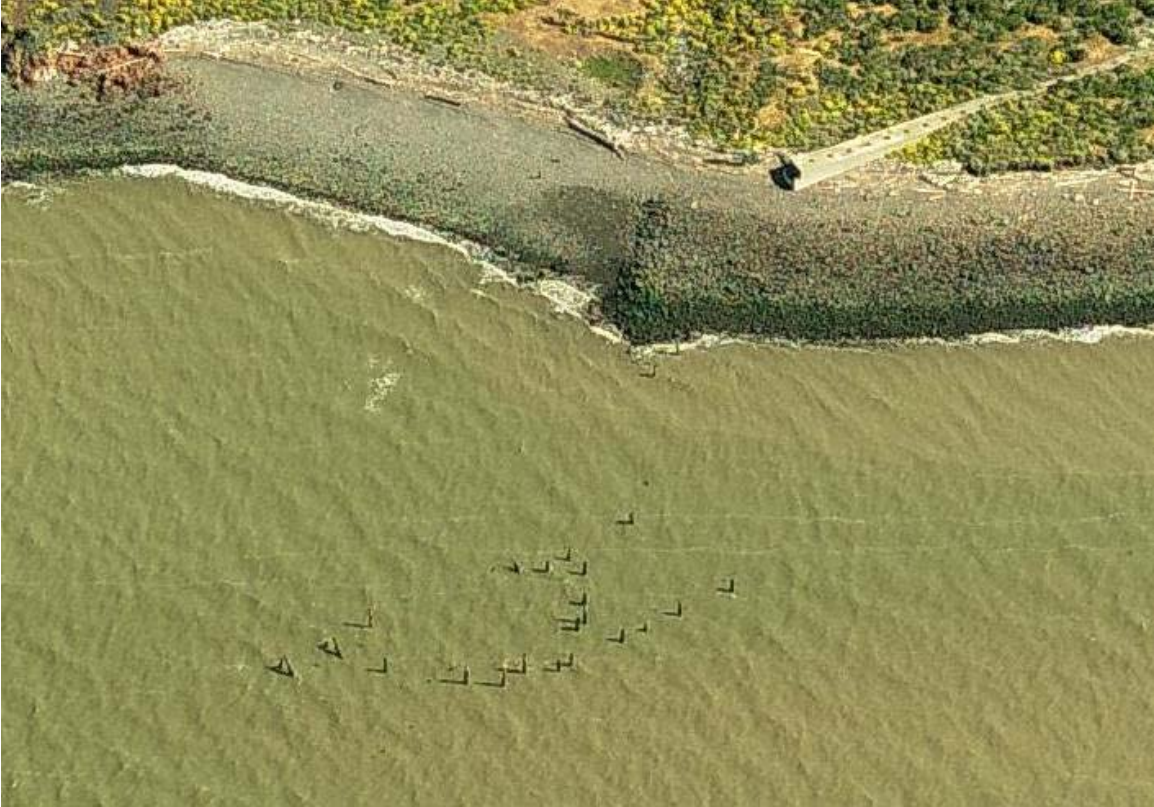
Figure 2-2. Bing Maps Birds Eye screenshot from the south side of Brooks Island, Richmond.

SFEI combined several software packages to gather information: Microsoft (MS) Bing Maps (formerly known as Virtual Earth), Google Earth, and ESRI ArcGIS. Each software package contributed to the value and accuracy of the dataset. The MS “Bird’s Eye” feature in Bing Maps offers high-resolution, oblique-angle 1998–2009 imagery for most of the San Francisco Bay shoreline (Pictometry 2009). SFEI used the Bird’s Eye feature to pan across the nearshore landscape and identify patches of pilings (e.g., Figure 2-2).

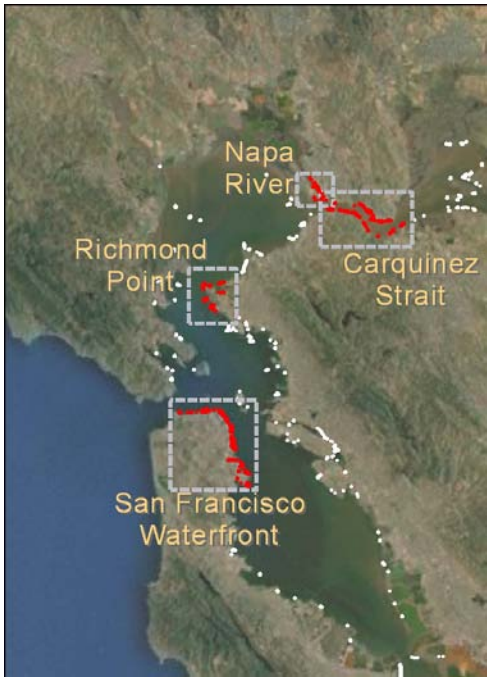
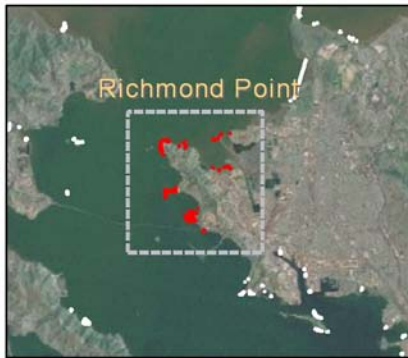
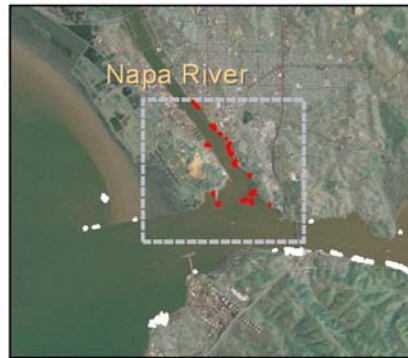
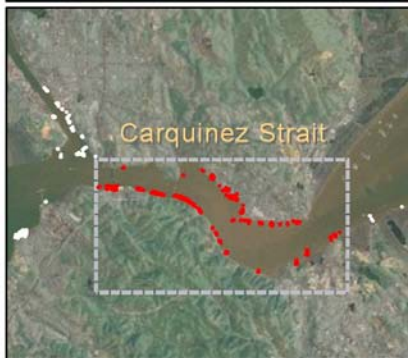
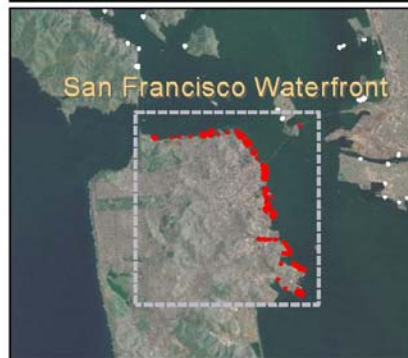
Four locations were chosen in areas of dense piling clusters. Piling count and piling complex count was calculated for each of these four areas. The shoreline was estimated manually in ArcMap using the measurement tool. The piling count and piling complex count was then normalized by this approximate shoreline count.

Figure 2-5. Piling hot spots.

Four locations had especially dense piling clusters: Carquinez Strait, Napa River, Point Richmond, and the San Francisco waterfront, specific site locations that sometimes crossed the boundaries of sub-regions. The areas were considered “hot spots,” a designation made solely because of the high density and not necessarily denoting a high level of contamination (Figure 2-5, Table 2-3).

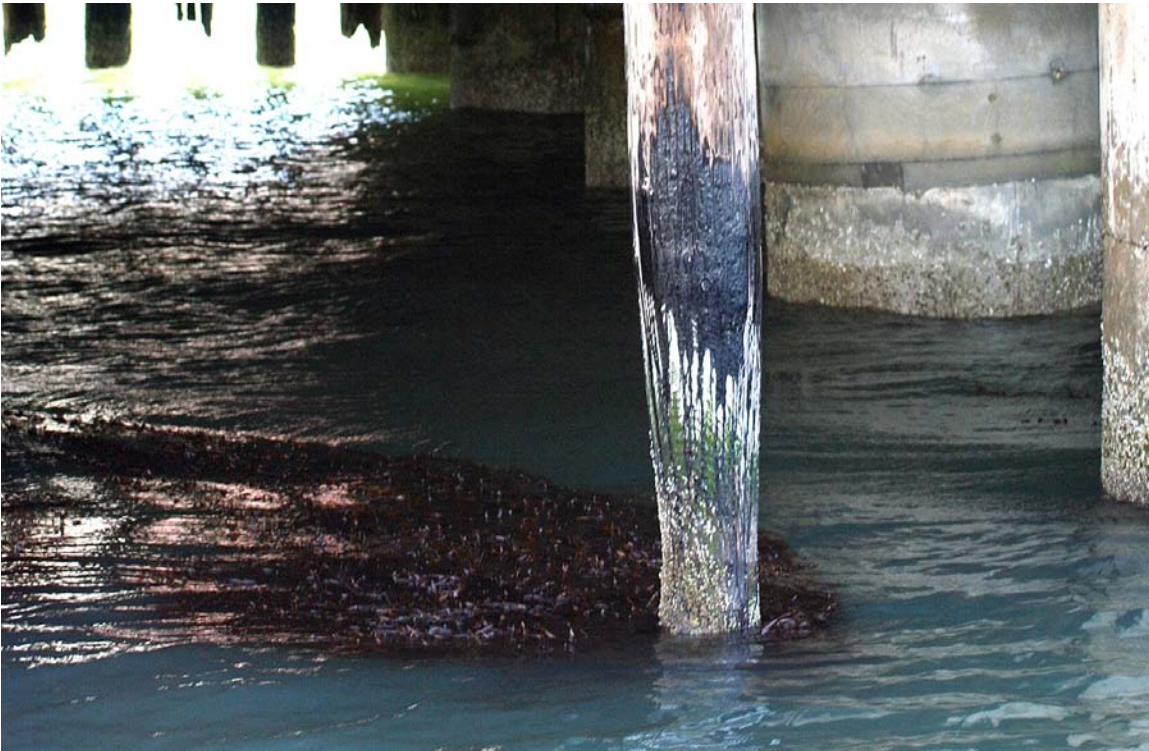
Figure 3-1. Visible creosote slick detected during field mapping in San Francisco Bay. (project team photograph)

1998). Studies suggest that most leaching occurs during the first few years after a pile is installed, but leaching may continue for many years. Studies conducted in Sooke Basin, British Columbia, suggested that the maximum migration of PAHs occurred during the first two to three years after installation (Brooks 1997, Goyette and Brooks 1998). The decreased level of creosote migration from older pilings is largely thought to be due to decreased surface availability. Creosote near the surface of the piling undergoes a “weathering” process, in which individual chemical constituents are adsorbed, evaporated, photo-oxidized, or dissolved (reviewed in Sved et al. 1997). However, the field mapping team for this project found visible slicks from piles in San Francisco Bay, all of which were installed more than 15 years ago (Figure 3-1).

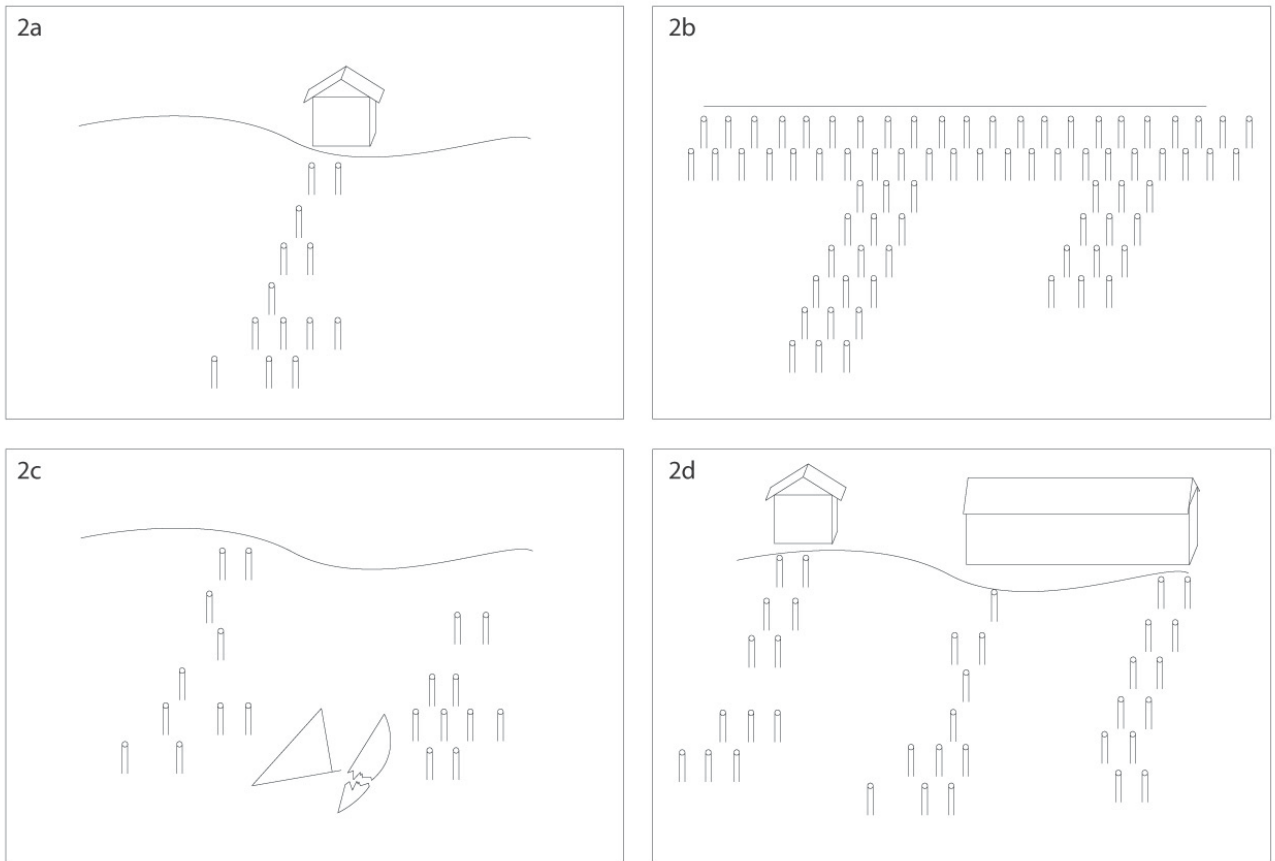
Figure 4-2. Piling significance scenarios: 2a, pilings associated with a significant onshore structure; 2b, extensive complex retaining ability to convey form, function, and association; 2c, association with an archeologically significant site; 2d, element in a multiple-property district.

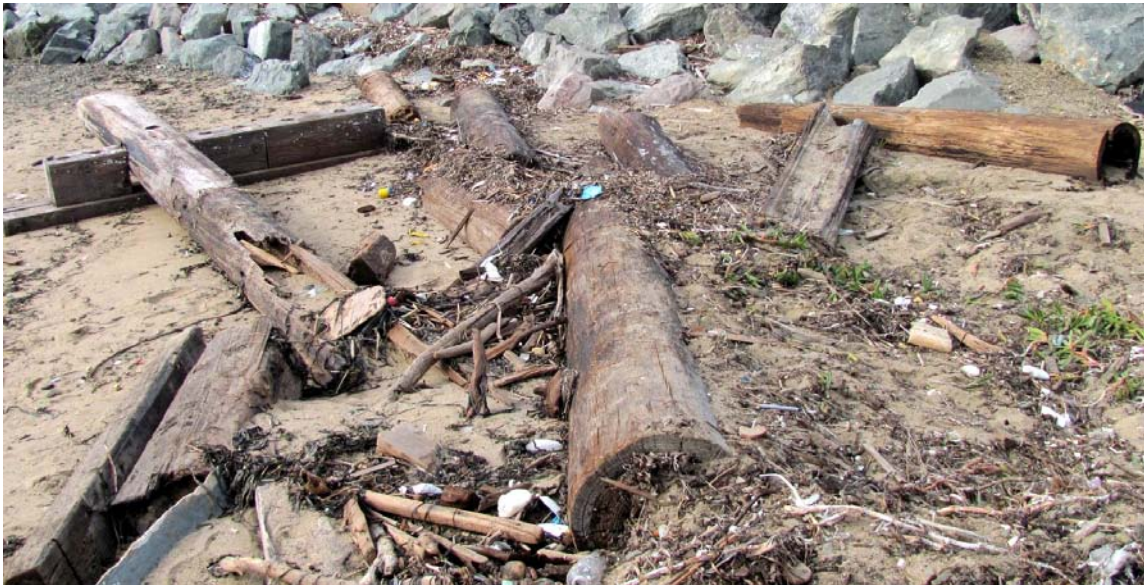
Figure 5-2. Intertidal debris at Point Richmond. (project team photograph)

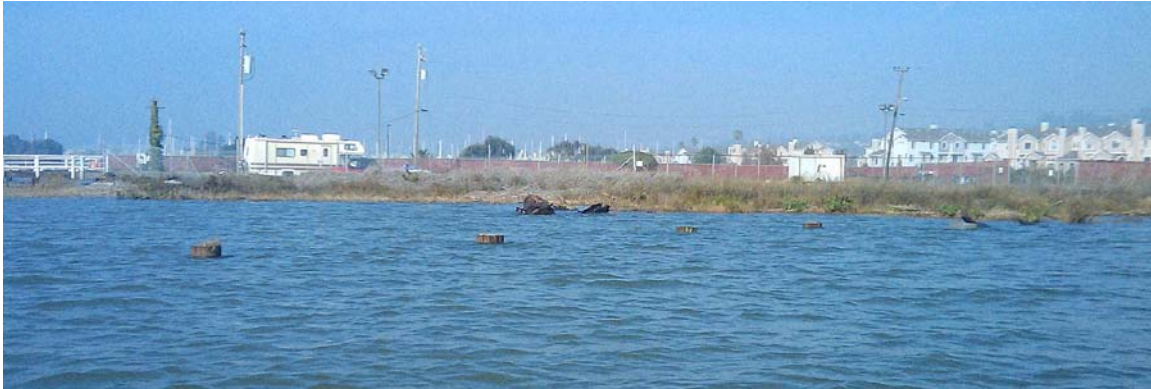
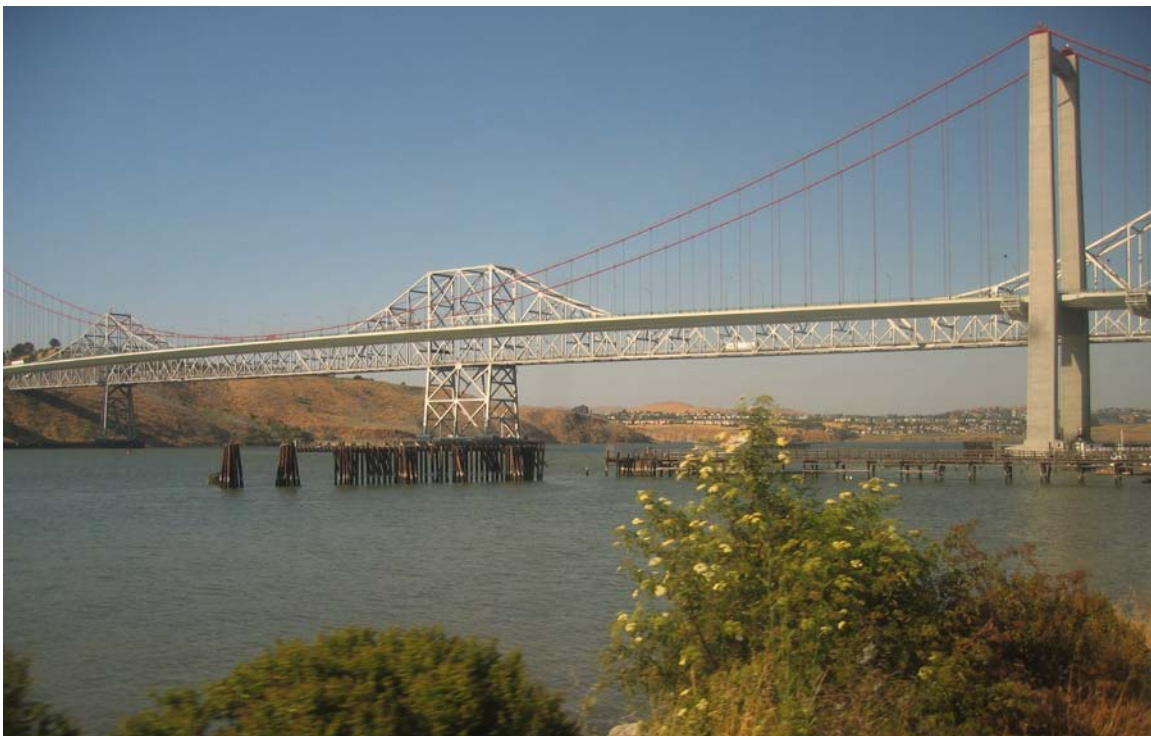
Figure 7-1. Old pilings may be hazards to navigation. (project team photographs)

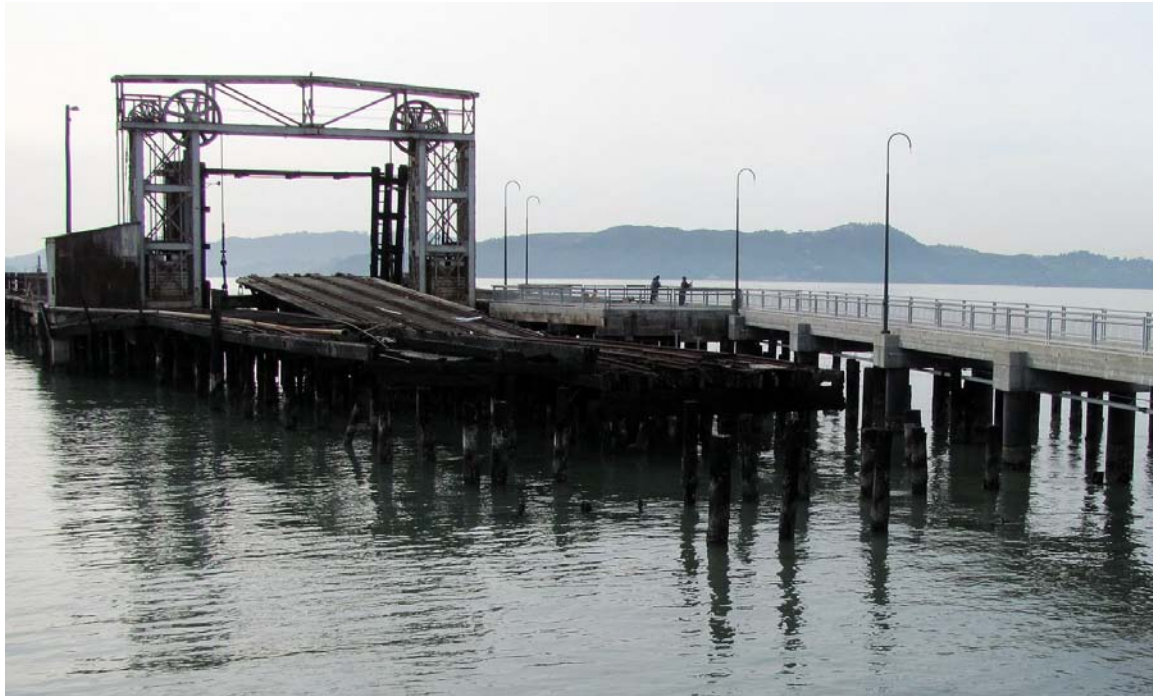
Figure 7-2. The old ferry terminal at Miller-Knox Regional Shoreline in Richmond is of historic interest. (project team photographs)

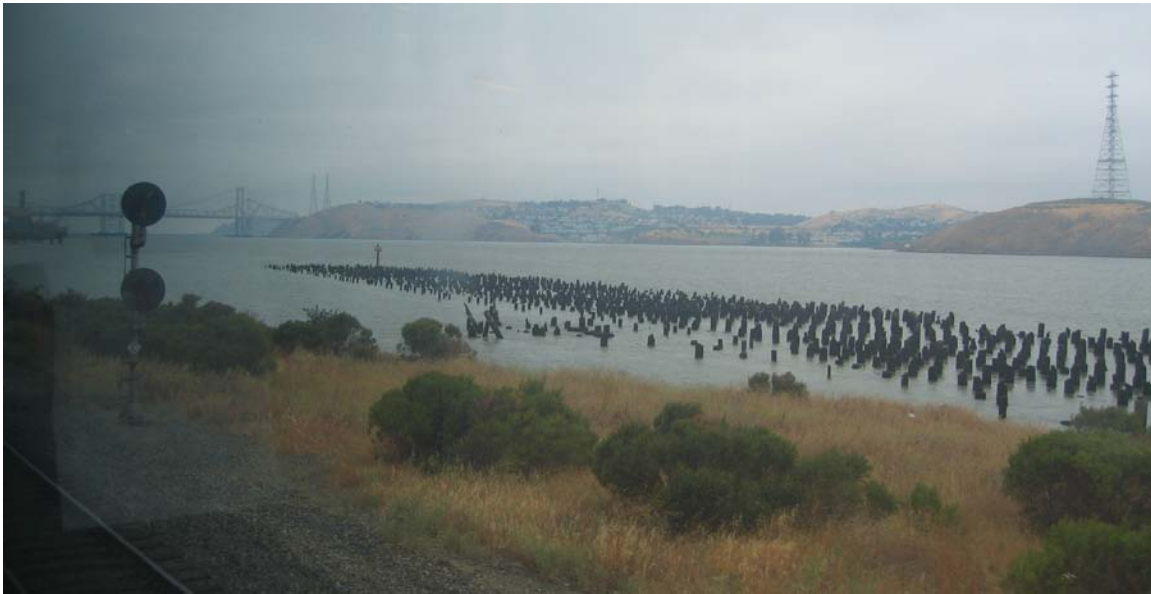
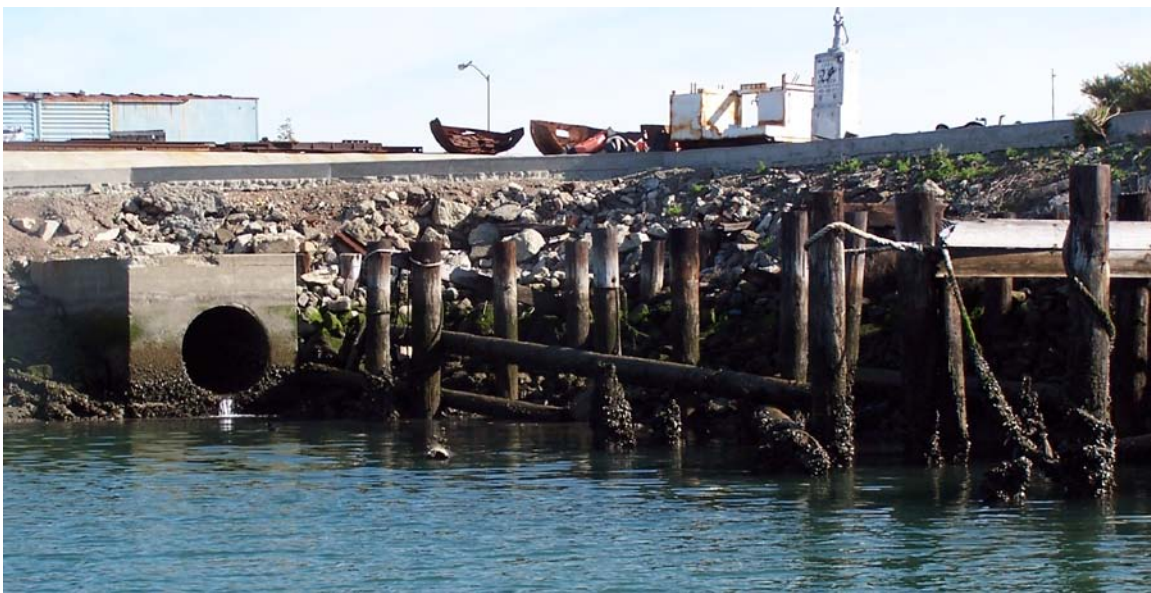
Figure 7-3. Abandoned pilings in San Francisco Bay—romantic reminders of the past or eyesores? (project team photographs)

In addition to historic interest, some pilings and structures may have aesthetic value, an attribute that is difficult to quantify (Figure 7-3). Assessment of aesthetic value varies widely among individual views and stakeholders. For many piles or piling groups, however, there may be consensus that the structures are eyesores, and those areas could be considered a high priority for removal. Like many coastal areas, San Francisco Bay is dealing with large increases of trash in our waters. Decrepit pilings and structures may be considered one form of trash. The NOAA Marine Debris Program focuses on preventing and removing debris from marine waters. Removal of creosote-treated wood from San Francisco's shorelines fits into this mission.

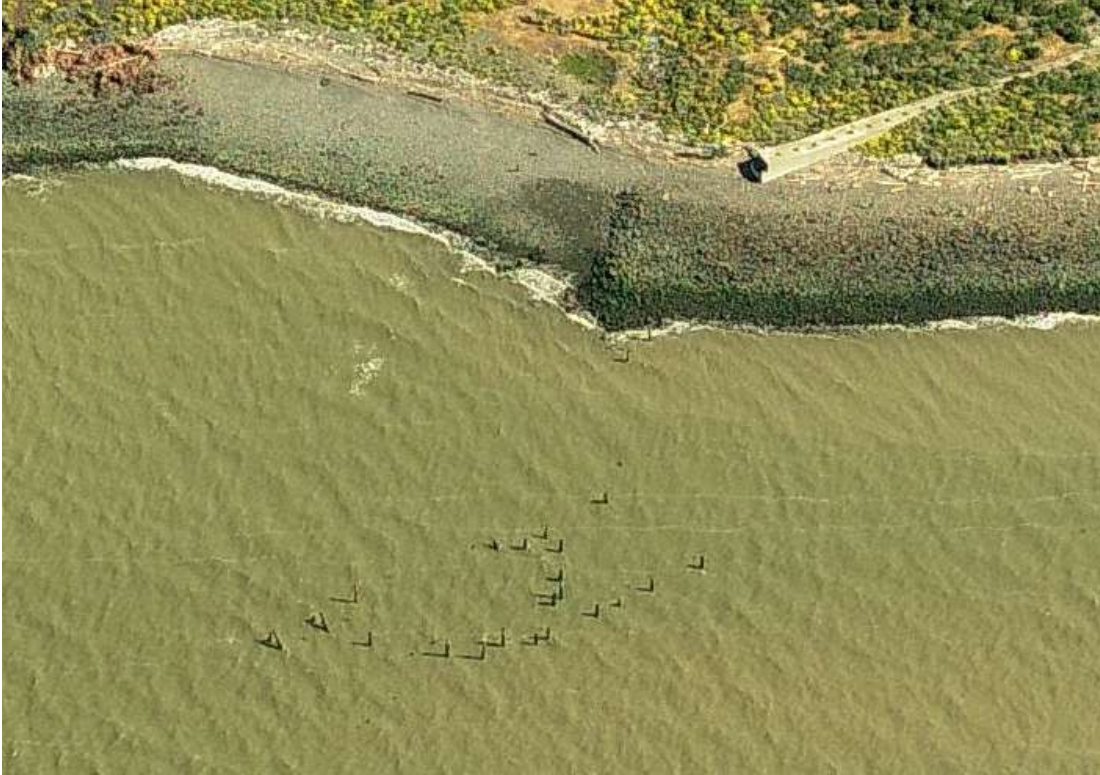
Figure 3 - Bing Maps "Birds Eye" screenshot from the south side of Brooks Island, Richmond, CA

Creosote pilings were identified in the ‘Bird’s Eye’ feature in Bing Maps by panning across the near shore landscape. Of the three software packages, Bing Maps offers the highest resolution imagery available, image capture dates ranging from 1998 to 2009, the option of an oblique angle and at low tide imagery (in some parts of the Bay). Low tide was useful, as some pilings are completely covered at higher tides. Then, delineation of the pilings and attribution of the polygons was completed in Google Earth. Google Earth has the functionality of creating and attributing polygons and higher resolution imagery than currently available for ArcGIS (although lower than Bing and not appropriate for initial piling identification). The data generated in Google Earth were processed and exported using the third party ‘Arc2Earth’ tool then analyzed in ArcGIS software. The final data will be available in proprietary (ArcGIS) and open source (kml/kmz) formats.

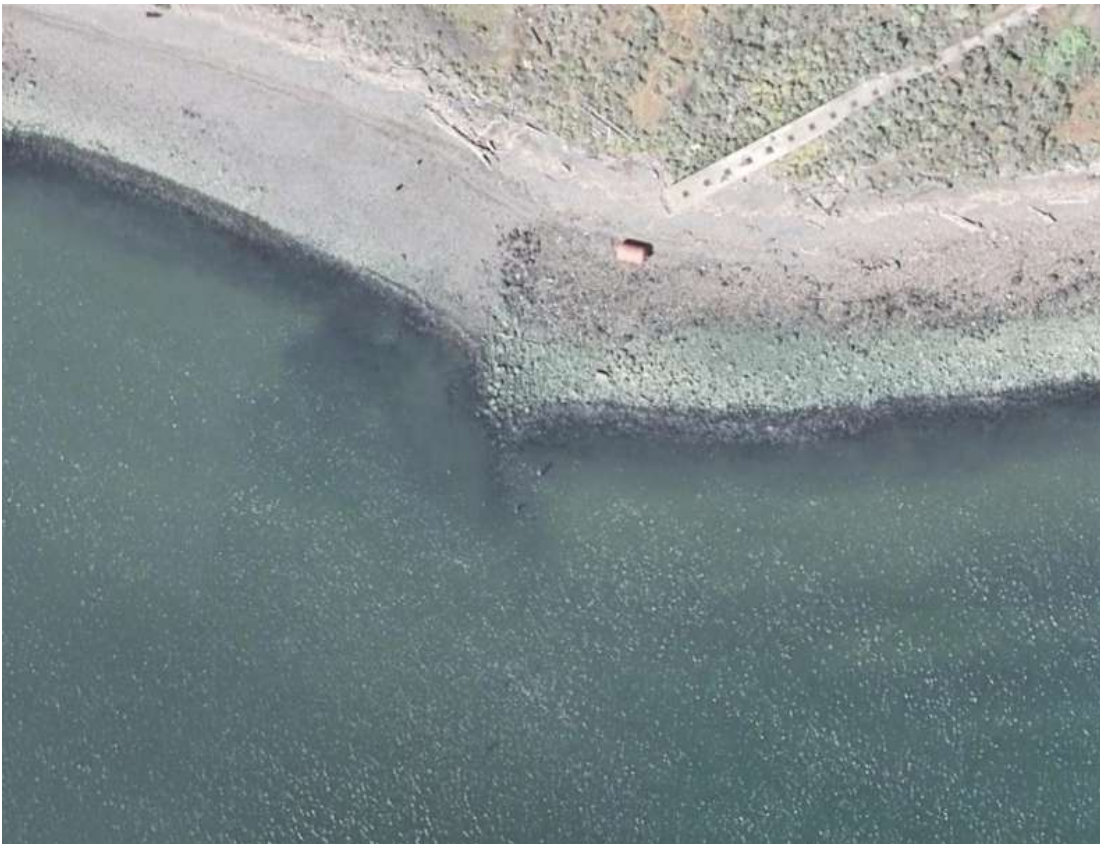
Figure 4 - Google Earth screenshot from the south side of Brooks Island, Richmond, CA

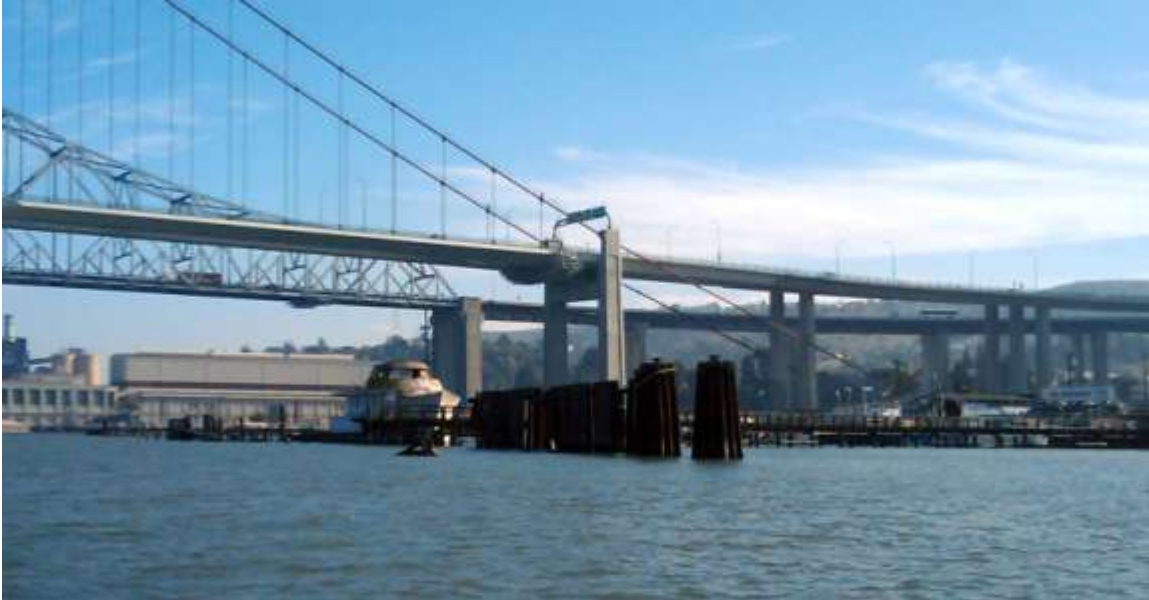
Figure 7 - Photo Taken beneath the south side of the Carquinez Bridge during QA/QC field work on December 11, 2008.

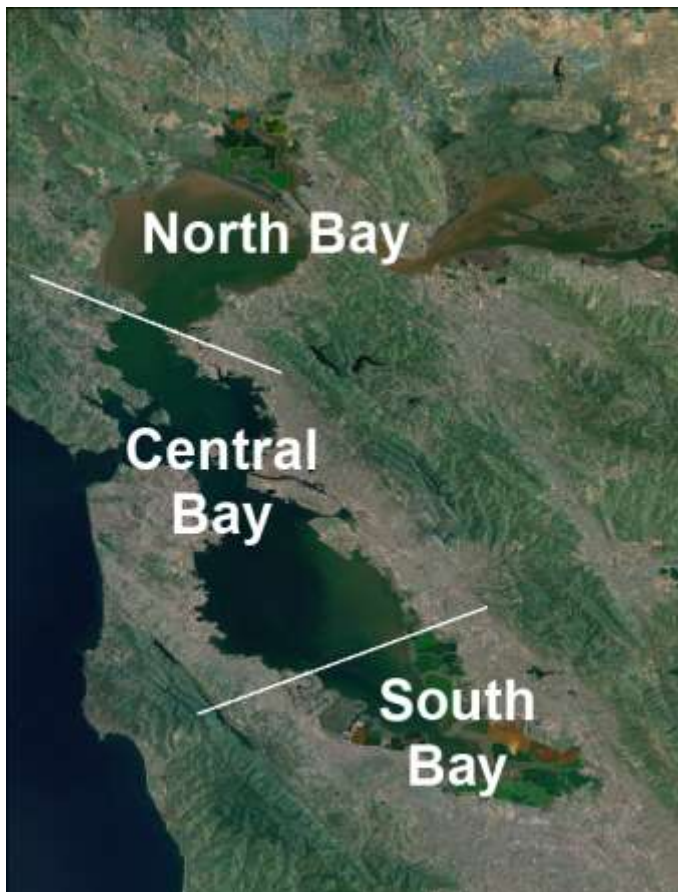
Figure 10 – Mapping Regions

Region	Number of pilings	Number of Complexes
Central Bay	15961	281
North Bay	14183	326
South Bay	402	23

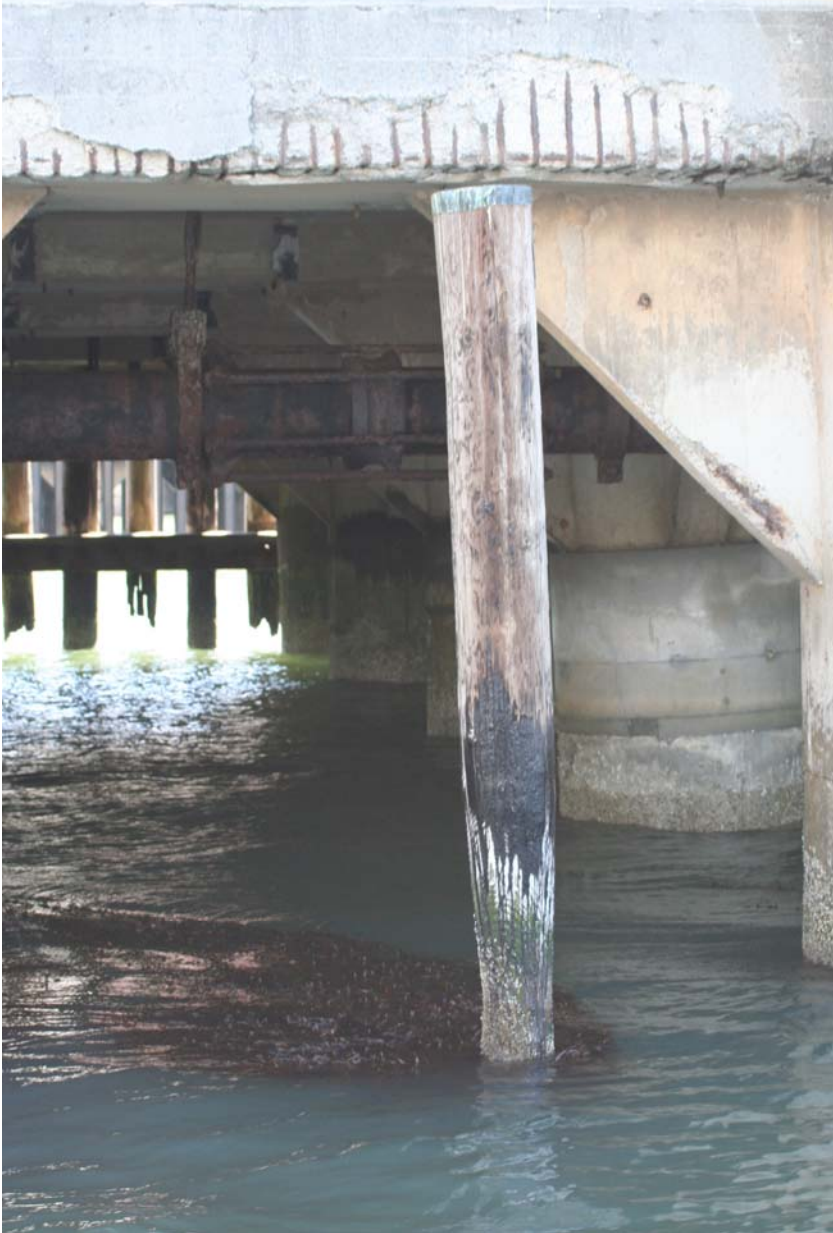
Figure 1. Creosote leaching from pier piling in San Francisco Bay as observed by NOAA survey 2008 (Photo credit: William Winner).

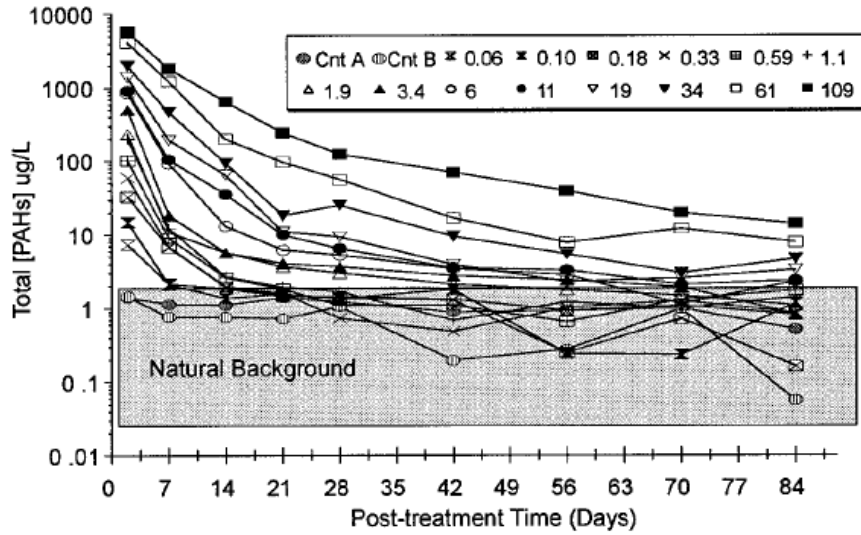
Figure 3. Total water PAH concentrations in µg/L over an 84 day experimental period using liquid creosote applied directly to aquatic microcosms (freshwater with sediment and PVC). Each line represents a distinct creosote microcosm treatment (14 microcosms of various creosote concentrations from 0.06 to 109 mg/L) (From Bestari et al., 1998b).

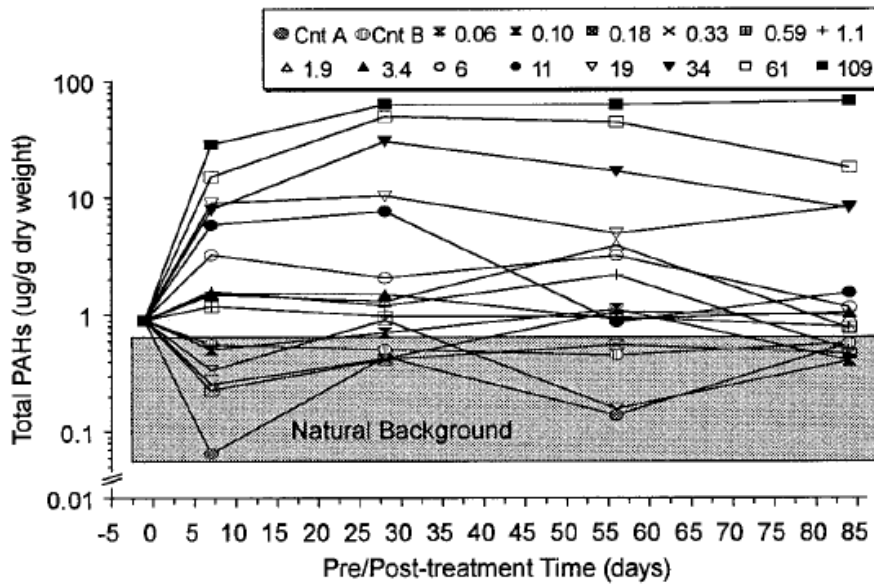
Figure 4. Total sediment PAH concentrations in µg/g over an 84 day experimental period using liquid creosote applied directly to aquatic microcosms (freshwater with sediment and PVC). Each line represents a distinct creosote microcosm treatment (14 microcosms of various creosote concentrations from 0.06 to 109 mg/L) (From Bestari et al., 1998b).

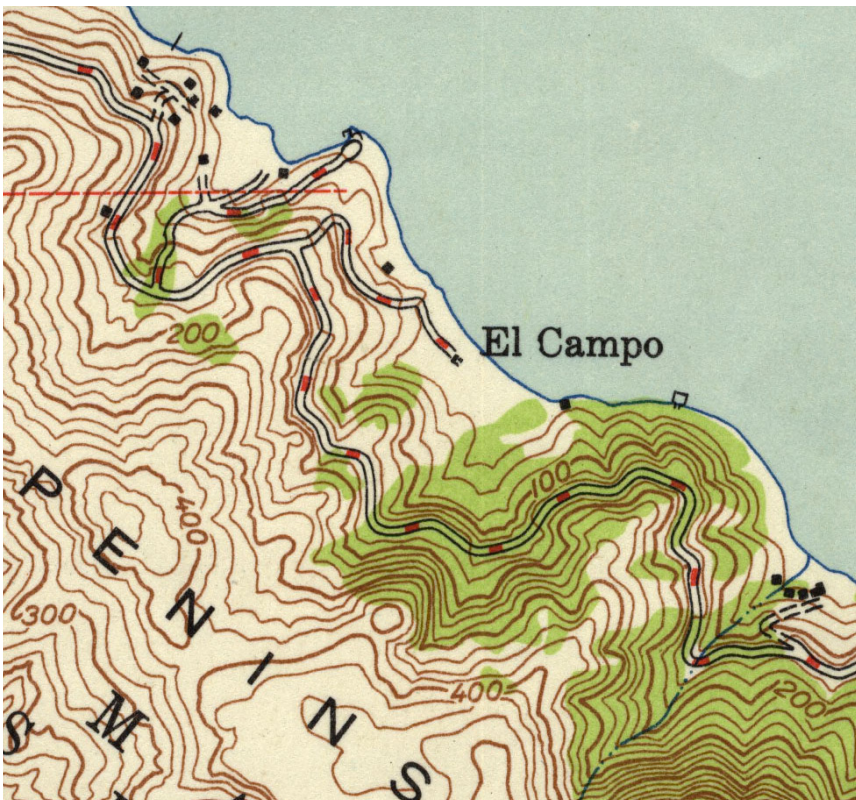
Figure 2. El Campo, 1947. No structures are present. A road, also shown on the 15' San Francisco quad in 1942, connects El Campo to Paradise Drive. (USGS 1947, courtesy of Earth Science and Map Library, UC Berkeley)

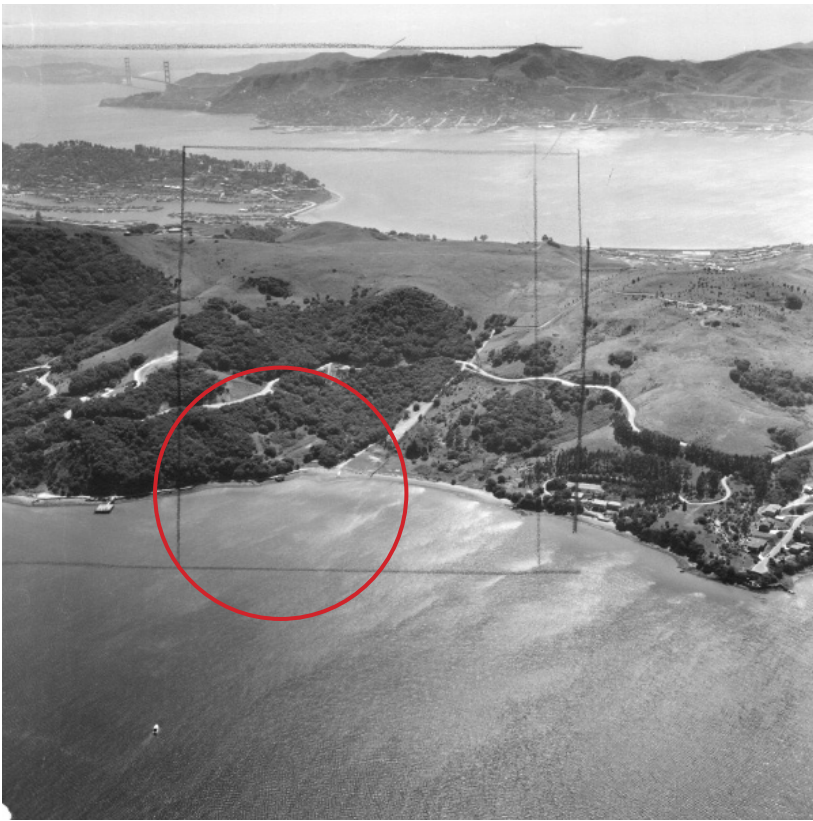
Figure 3. El Campo, 1959. Neither structure is present and no fill has been added. (Brady 1959, courtesy of Marin History Museum)

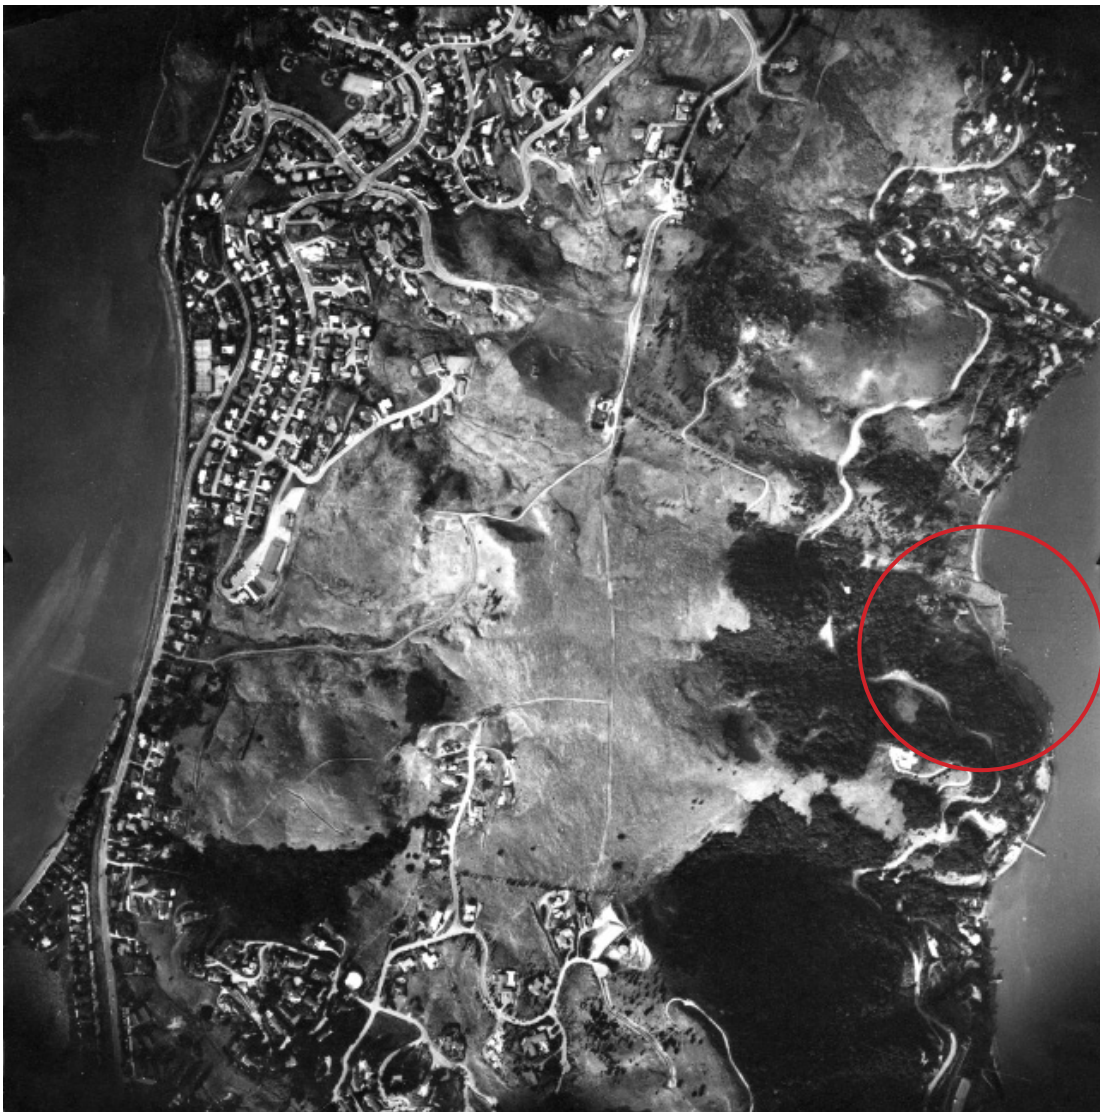
Figure 5. El Campo, 1969. The marina was abandoned sometime between March 1967 and August 1968. Dividers between boat docks have been dismantled and very little remains of the site even in the late 1960s. Gangways can still be seen connecting the filled land to the marina. (Brady 1969, courtesy of Marin History Museum)
