SAN FRANCISCO BAY SUBTIDAL HABITAT GOALS REPORT

Appendix 6- I: Removal of Creosote-Treated Pilings and Structures from San Francisco Bay

Removal of Creosote-Treated Pilings and Structures from San Francisco Bay

December 10, 2010

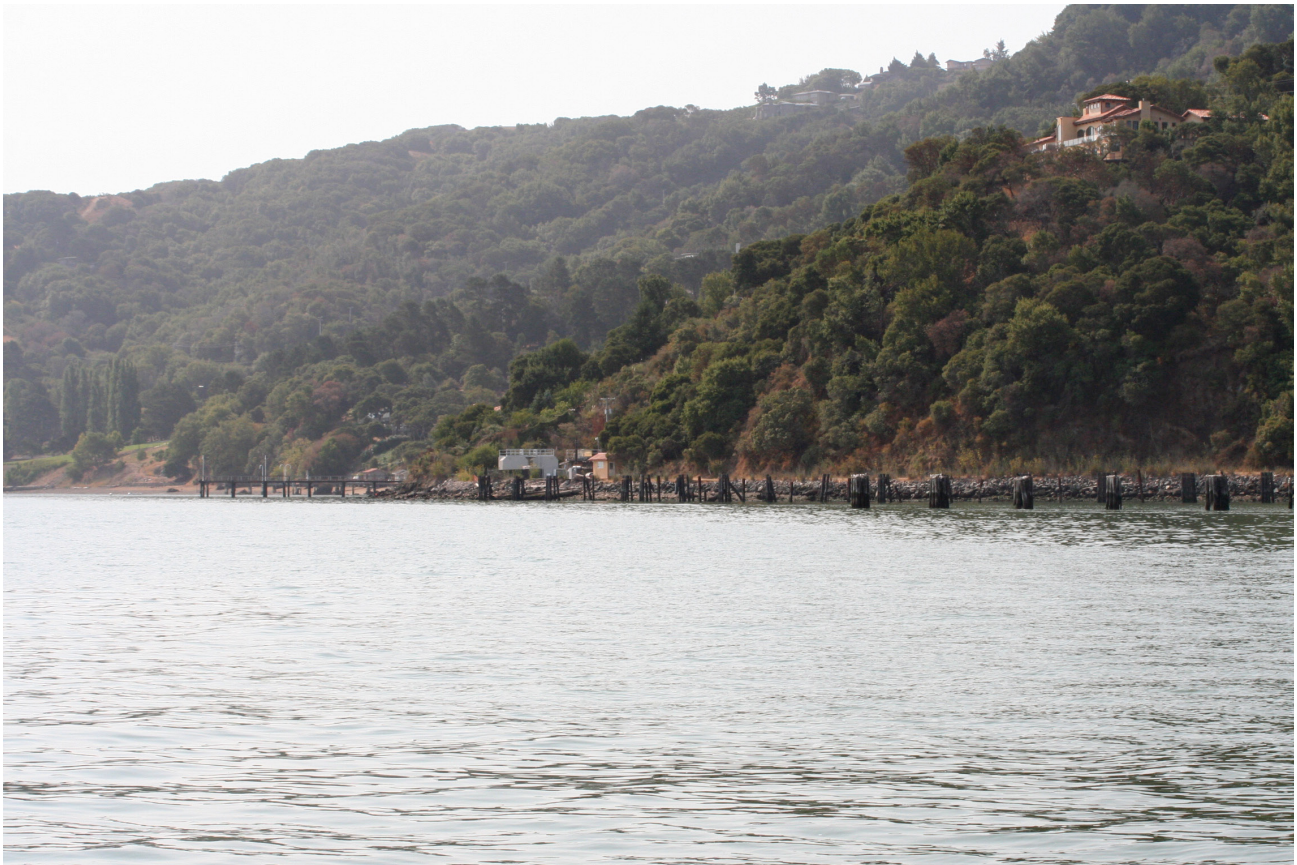
Figure 6. Abandoned bulkhead, 2008. (Courtesy of NOAA)

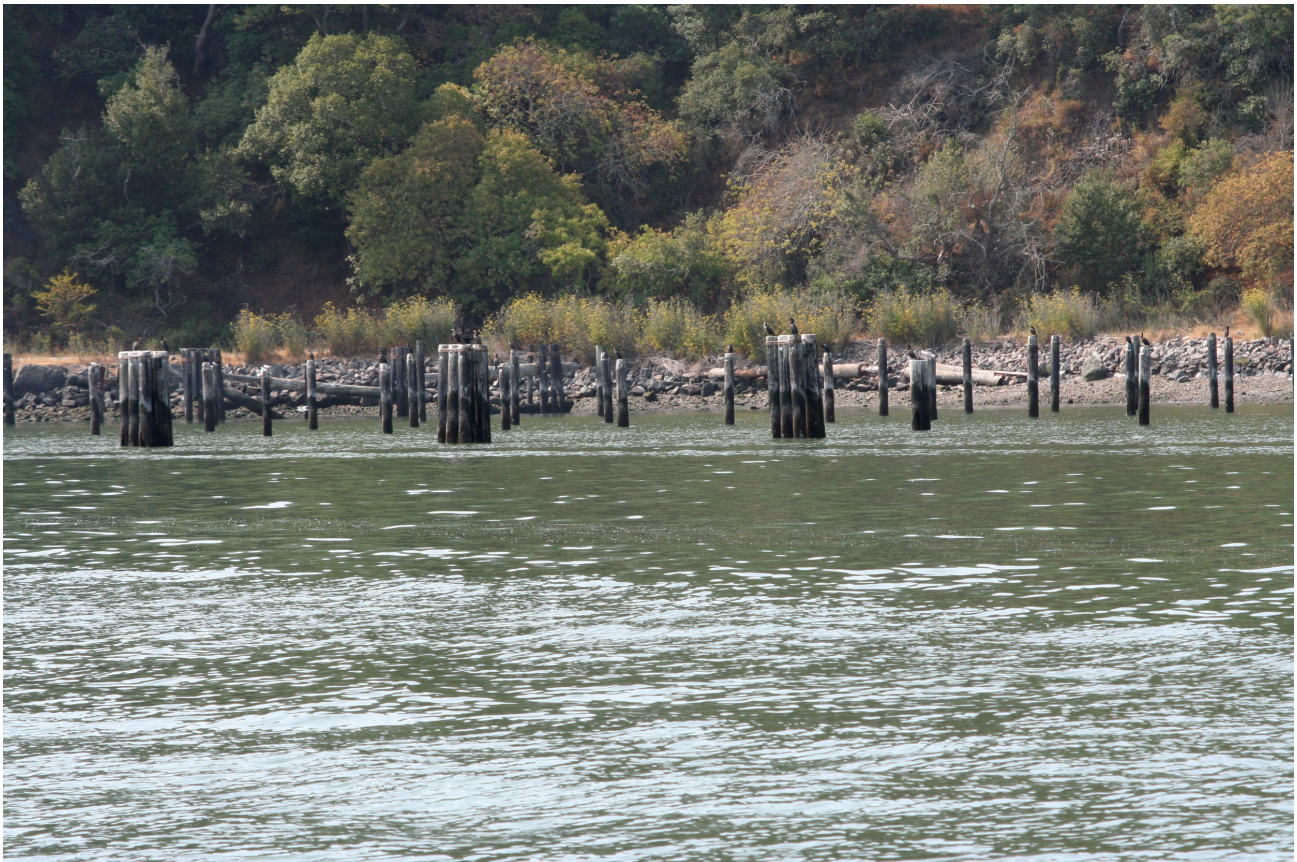
Figure 7. Abandoned bulkhead, 2008. (Courtesy of NOAA)

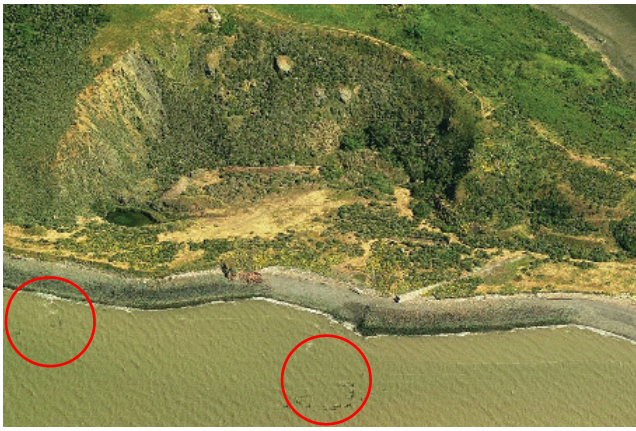
Figure 1. Brooks Island, 2009. The remains of two wharves are faintly visible at the bottom of the image (circled in red). The hillside has been carved out as a result of quarrying operations. (Courtesy of Bing Maps)

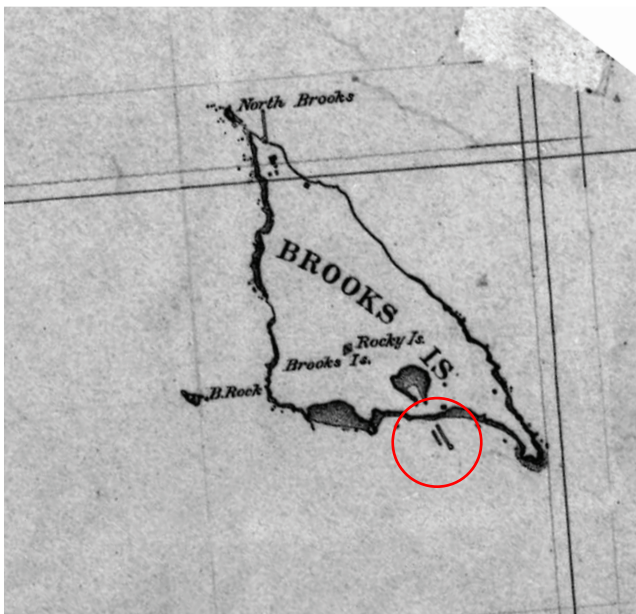
Figure 2. Brooks Island, 1895. Only one structure is present on the south side of the Island. (USCGS 1895, courtesy of IMC)

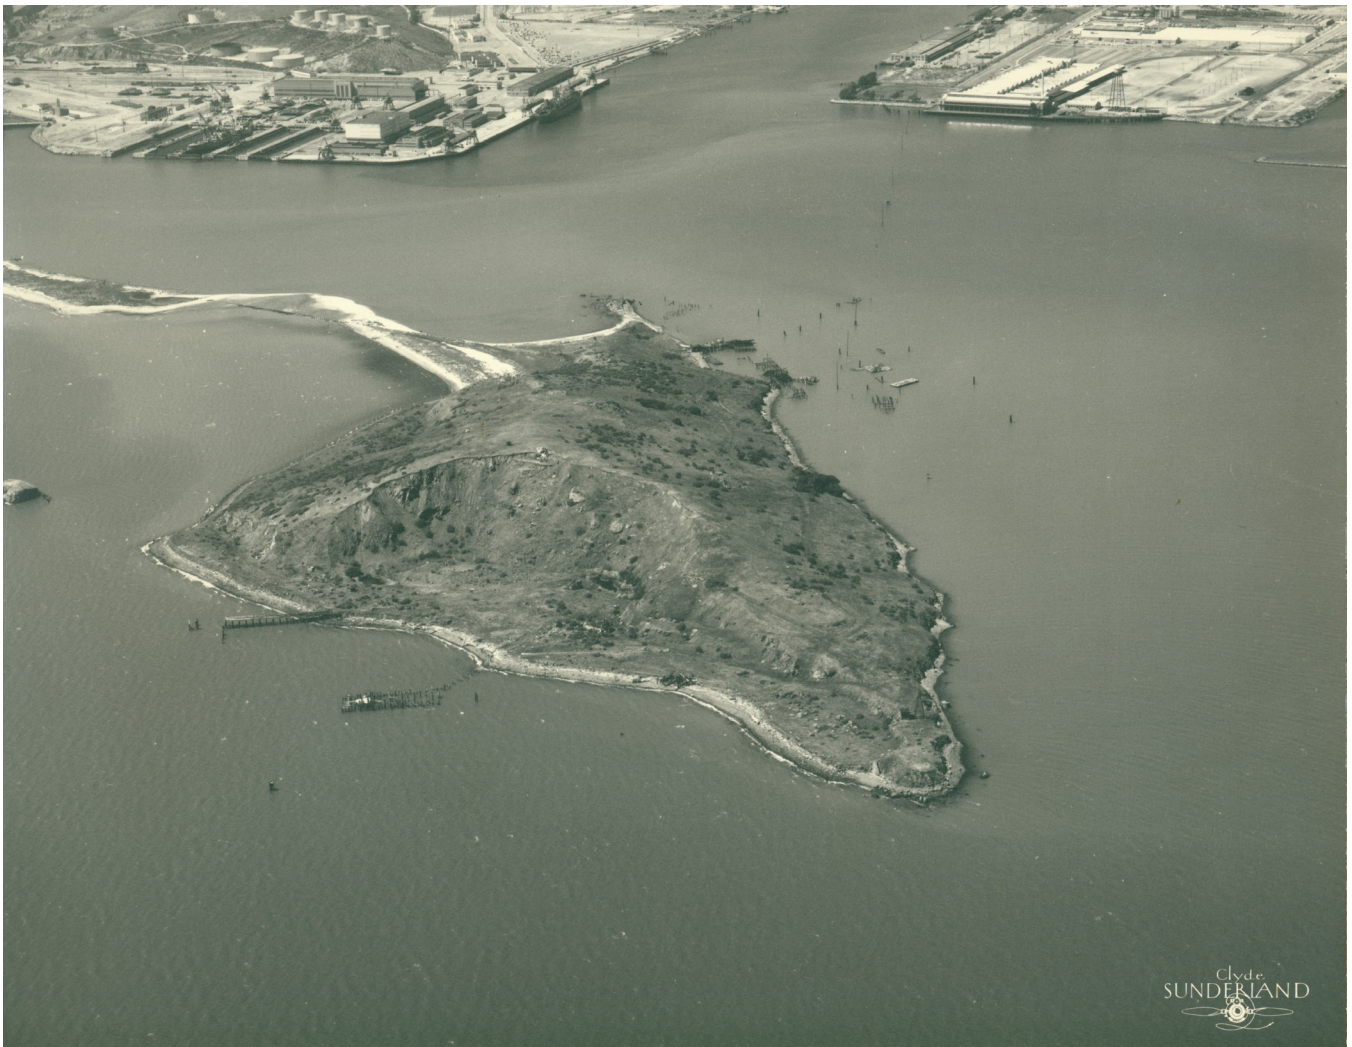
Figure 6. Brooks Island, 1955. Two structures are still present, though both are in states of disrepair. (Sunderland ca. 1955, courtesy of the Richmond Museum of History)

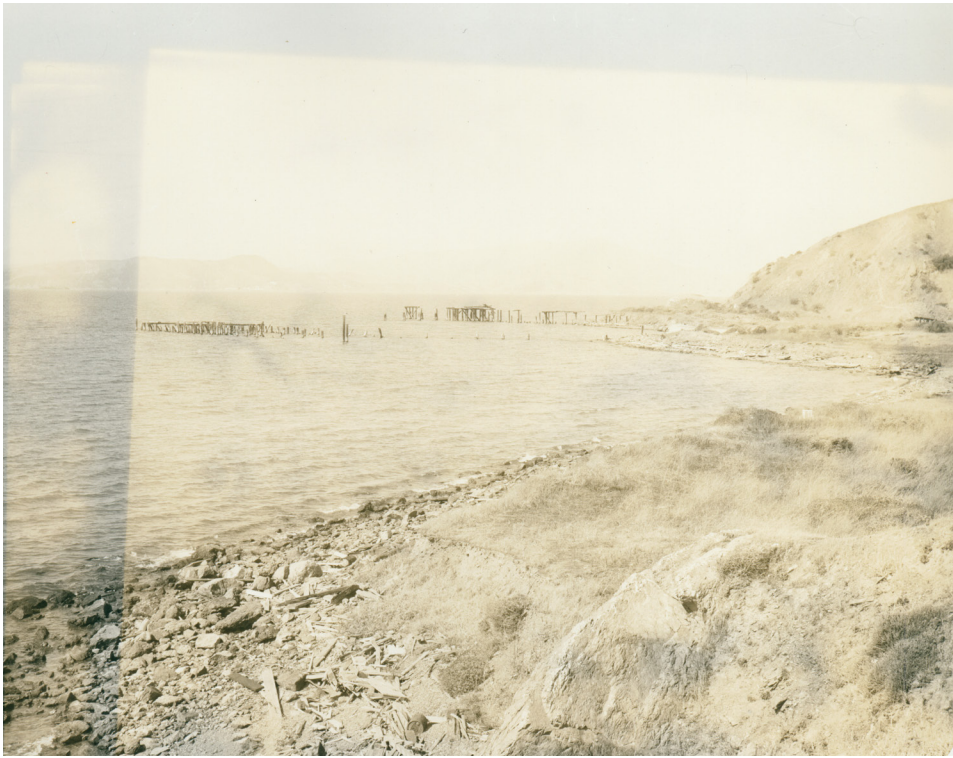
Figure 7. Brooks Island, 1961. Looking west. The remnants of both structures are visible, and look similar to modern condition. (Unknown ca. 1955, courtesy of the Richmond Museum of History)

The quarry, structures, and wharves on the southern end of the island have been neglected since 1939, and the piers have been left to decay (figs. 6-8). Construction has been focused on the northern end of the Island: Bing Crosby and his Sheep Island Gun Club constructed a pier to the north, and the U.S. Army Corps of Engineers built a breakwater for the port of Richmond between 1924 and 1931 (Collier 1983). The Island received little attention until the opening of Brooks Island as part of the East Bay Regional Parks District in 1990 (Rego 1996b).

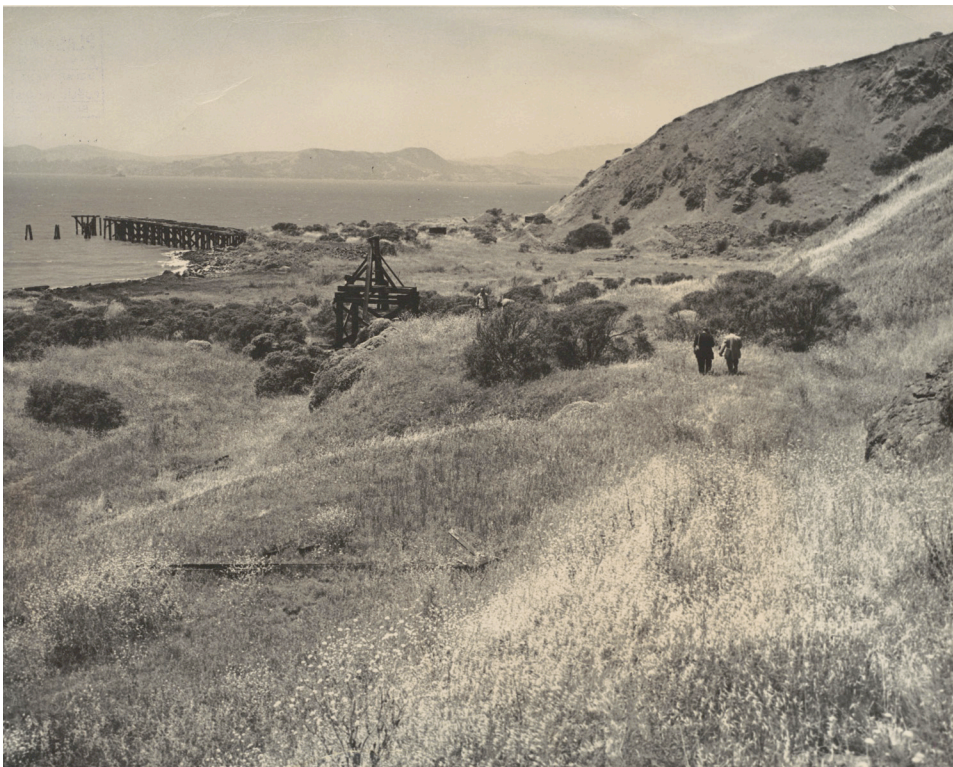
Figure 8. Brooks Island, ca. 1960. Looking west, the remains of the western wharf are visible. (Unknown ca. 1960, courtesy of The Bancroft Library, UC Berkeley)

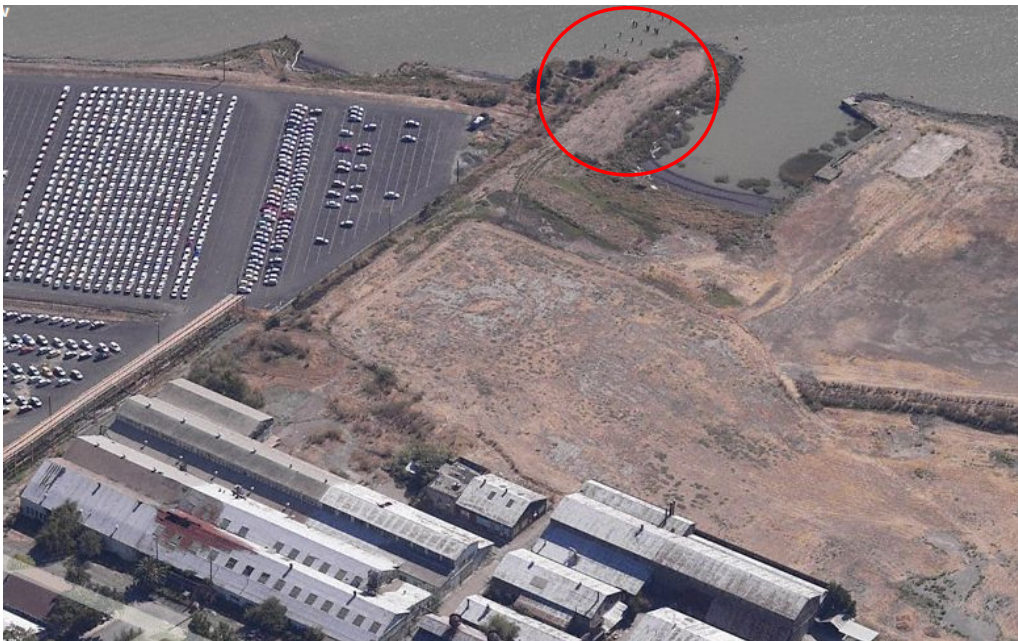
Figure 1. Seventh Street Pilings, looking south, 2009. The pilings are located south of Benicia, west of the auto-off-loading area and east of a constructed inlet. The remains of the Yuba Manufacturing Co. (bottom left) and the pilings (circled) can be seen. (Courtesy of Bing Maps)

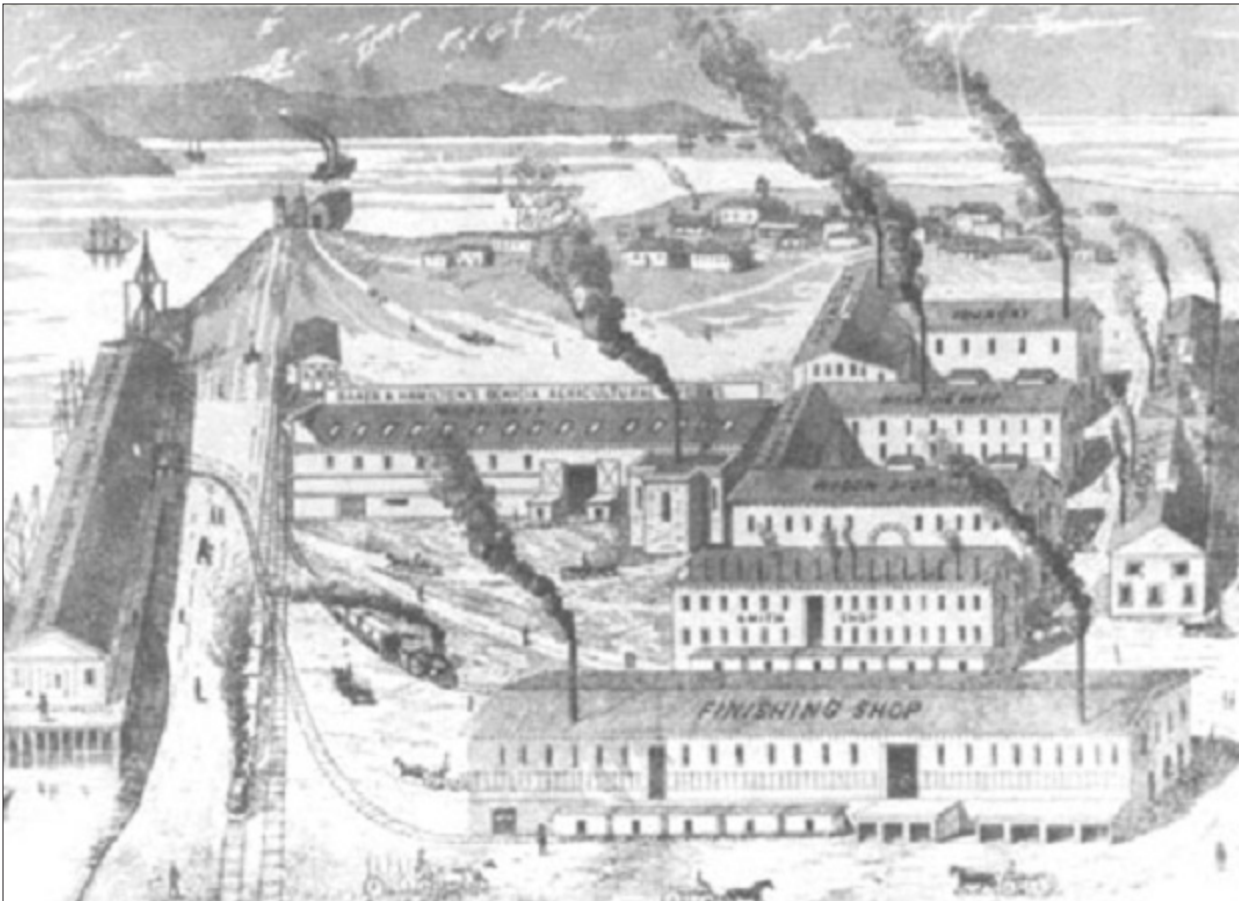
Figure 3. Benicia Agricultural Works and wharf, ca. 1881. The long structure on the left is the wharf constructed by Pacific Mail and purchased by Baker and Hamilton (later the Benicia Agricultural Works) in 1879. (Wassman and Bussinger 2004, courtesy of the Benicia Historical Museum)

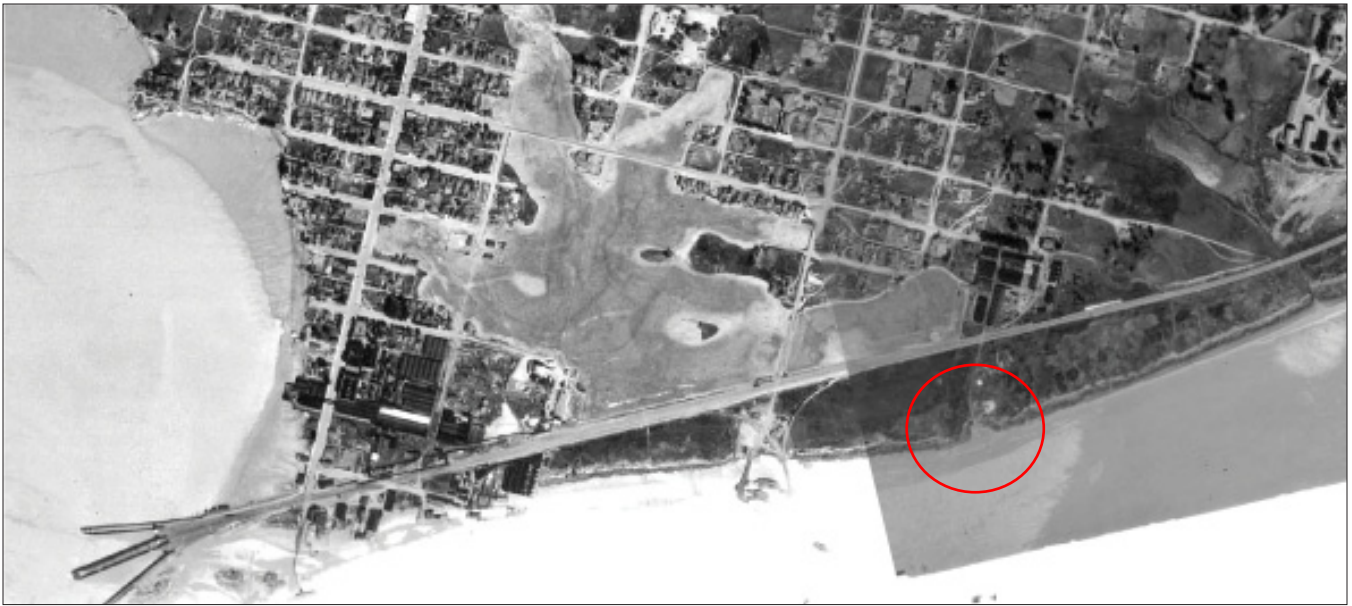
Figure 7. Yuba Manufacturing Company, 1928-9. The Yuba Manufacturing Company purchased the east Benicia property in 1914; it appears that shortly thereafter they stopped using the wharf. By 1928 there is no structure visible at the location of the former Pacific Mail and Benicia Agricultural Works wharf. (Unknown 1928-9, courtesy of Earth Sciences and Map Library, UC Berkeley)

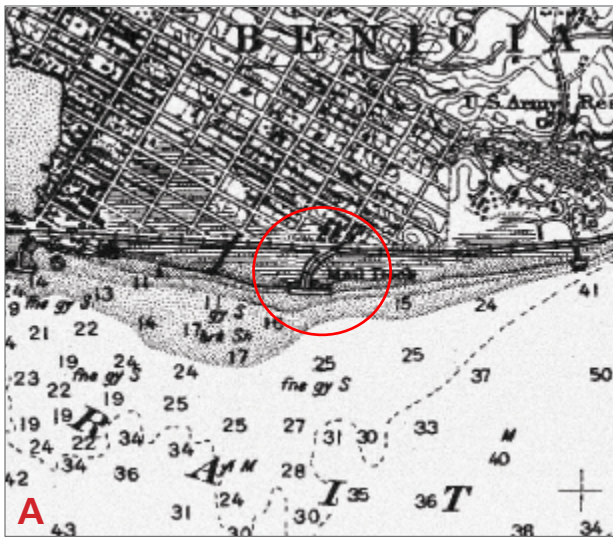
Figure 9. Benicia Agricultural Works wharf, 1910 and 1948. A 1910 coast survey map shows the shape and structure of the wharf at the end of Seventh street and labels it a “mail dock” (A). The 1948 resurvey shows a group of pilings in the same position and are oriented in a similar manner as the 1910 wharf (B). (Jones 1910 and Colbert 1948, courtesy of NOAA)

It seems likely that Yuba either removed the wharf and warehouse, or allowed them to decay. There is little evidence of what happened to the wharf after 1942. However, one map from the late 1940s reveals pilings that appear to be the footprint of the old wharf (Colbert 1948; fig. 9). They are in the correct location and are organized in a narrow line running parallel to the shore, reflecting the position and shape of the original wharf. Yuba Manufacturing Company closed down in 1973.
