San Francisco Bay Living Shorelines: Near-shore Linkages Project:

Progress and Preliminary Results

Report submitted to the San Francisco Estuary Partnership for EPA Water Quality Improvement Fund Phase II

Covering Activities September 2012- September 2013

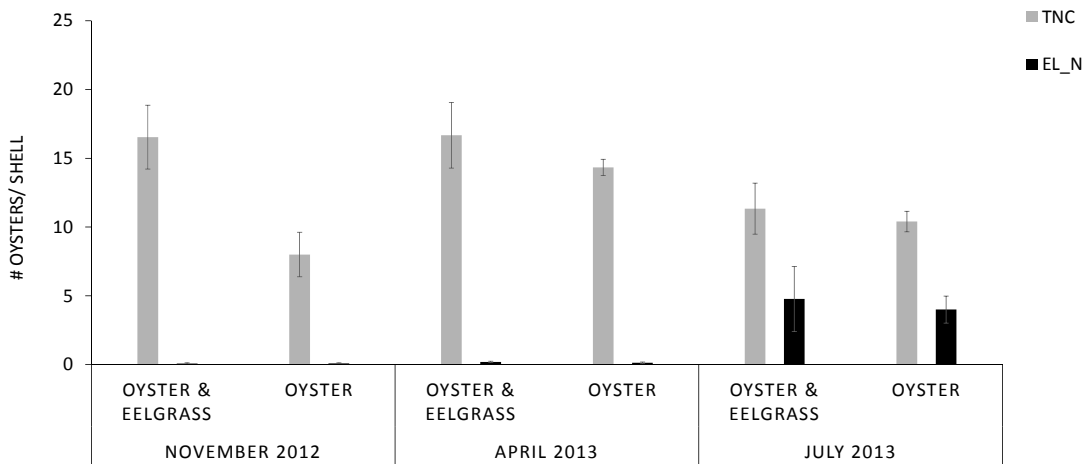
Figure A-1. Number of oysters per shell in sample shell bags for three time points, in the oyster and eelgrass plots and the oyster-only plots, for both locations. TNC = The Nature Conservancy property in San Rafael; EL_N = the Eden Landing North site, at the Hayward shoreline.

Recruitment in 2012, first recorded in November that year, was much higher at the TNC site than at Eden Landing (Figure A-1). Survival was high at TNC, with large numbers of oysters still growing on shell bags throughout our most recent monitoring event in July this year. We frequently observed drill holes on the shells of dead oysters in our shell bags from Eden Landing. Initially, there was a trend of higher numbers of oysters to shell bags in the oyster-eelgrass plots than to the oyster-only plots, but this pattern was not apparent in subsequent time points (Figure A-1). Oysters at TNC were also larger than oysters at EL (Figure A-2). Our July 2013 monitoring appears to have happened before the main recruitment season for

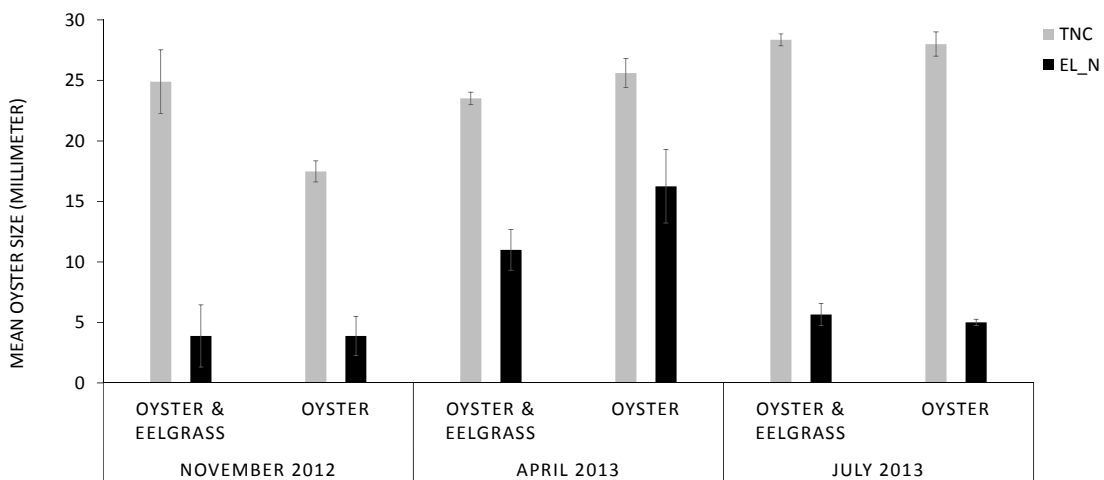
Figure A-2. Sizes of oysters sample shell bags for three time points, in the oyster and eelgrass plots and the oyster-only plots, for both locations.

TNC = The Nature Conservancy property in San Rafael; EL_N = the Eden Landing North site, at the Hayward shoreline.

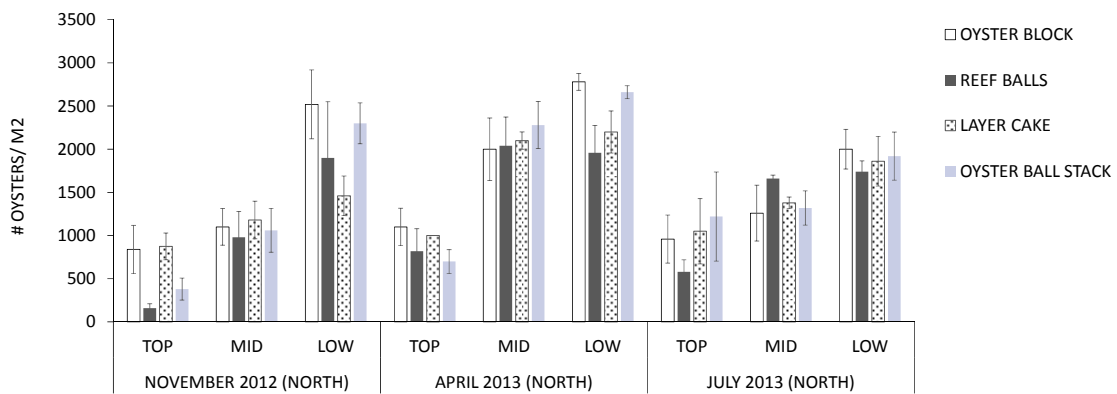
Figure A-4. Number of oysters per m² at TNC. Surveys were conducted on north facing vertical surfaces on three dates: November 2012, April 2013, and July 2013.

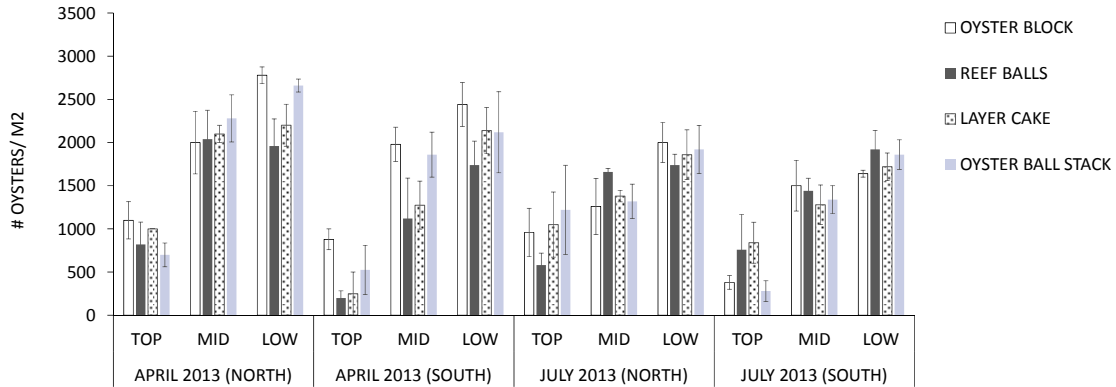
Figure 3: TNC mean north vertical surface oyster density. Surveys were conducted on north facing vertical surfaces on three dates: November 2012, April 2013, and July 2013.

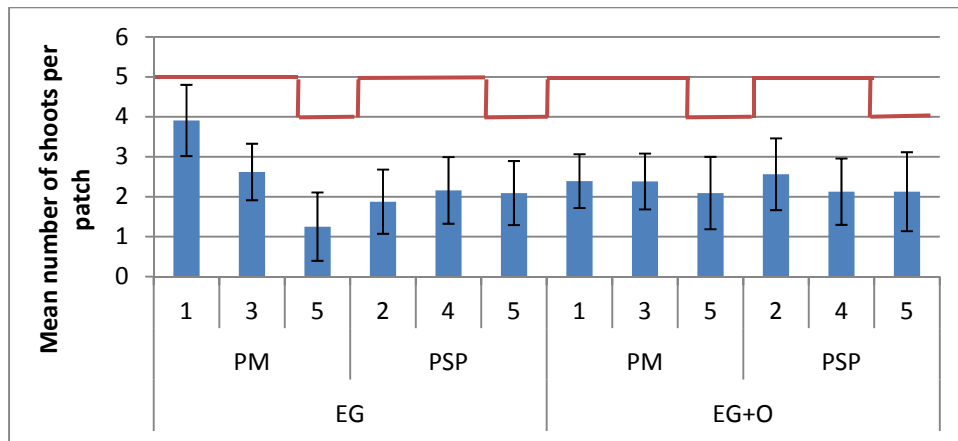
Figure B-7a – Mean number of vegetative shoots per patch, donor and treatment plot at TNC in July 2013. Horizontal axes labels 1 – 5 refer to the clockwise numbering of patches of eelgrass as shown in figure 3. Original plant numbers in each patch was 5 plants in patches 1, 2 3 and 4 and 4 plants in patch 5 making a total of 24 plants per eelgrass unit. The red line indicates the original plant numbers in each patch. EG = eelgrass only plot, EG+O = eelgrass and oyster substrate plot, PM = plants from the Point Molate donor site and PSP = plants from the Point San Pablo donor site. Error bars = 95% confidence intervals.

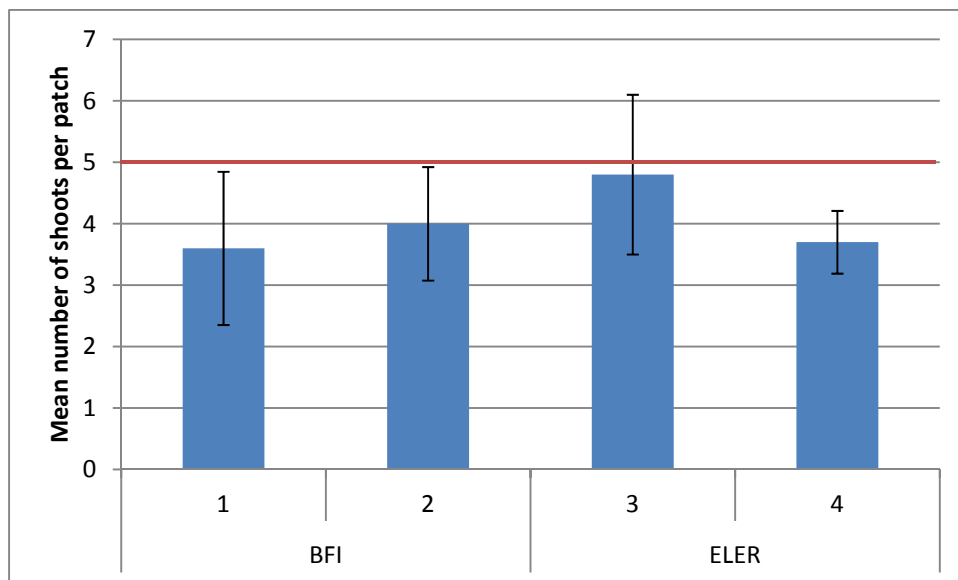
Figure B-7b – Mean number of vegetative shoots per patch and donor at Eden Landing, Hayward. Horizontal axes labels 1 – 4 refer to the clockwise numbering of patches of eelgrass as shown in figure 3. Five plants were planted in each patch making a

total of 20 plants per eelgrass unit. The red line indicates the original plant numbers in each patch. BFI = plants from Bay Farm Island, ELER = plants from Eden Landing. Error bars = 95% confidence intervals.

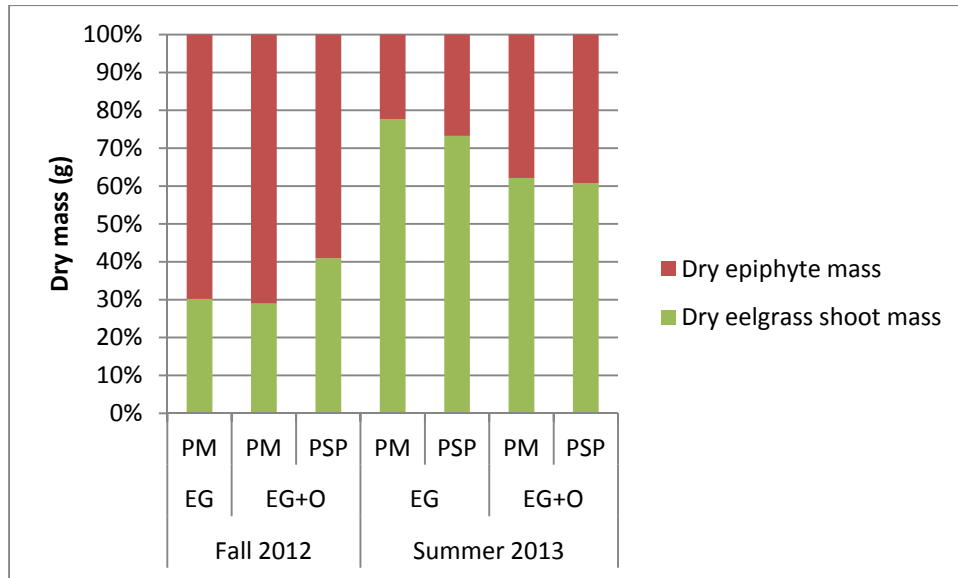
Figure B-10 –Mean epiphyte load, shown as a percent of dry mass, collected at The Nature Conservancy site in fall 2012 and summer 2013. EG = eelgrass only plot, EG+O = eelgrass + oyster substrate plot, PM = plants from the Point Molate donor site and PSP = plants from the Point San Pablo donor site. Note that Fall 2012 samples included only leaf #4 to avoid removing whole plants when there were few. Leaf #4 is an older leaf and likely to have proportionally greater epiphyte biomass per g of eelgrass biomass than would whole shoots, as were collected in summer 2013.

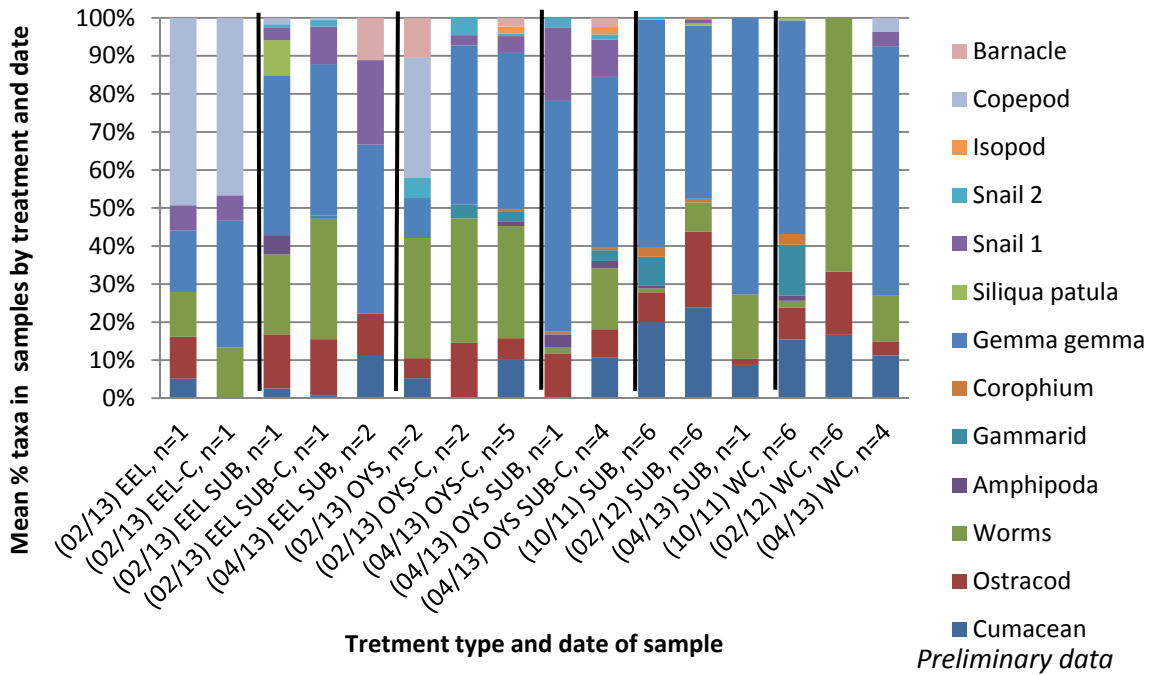
Figure B-13. Preliminary mean aquatic invertebrate abundance data (sample sizes vary) collected by suction sampling in 0.25m x 0.25m quadrat during baseline sampling (October 2011, February 2012) and post-treatment sampling (February 2013 and April 2013) at the ELER site. Data collected and compiled by SFSU 2011-2013.

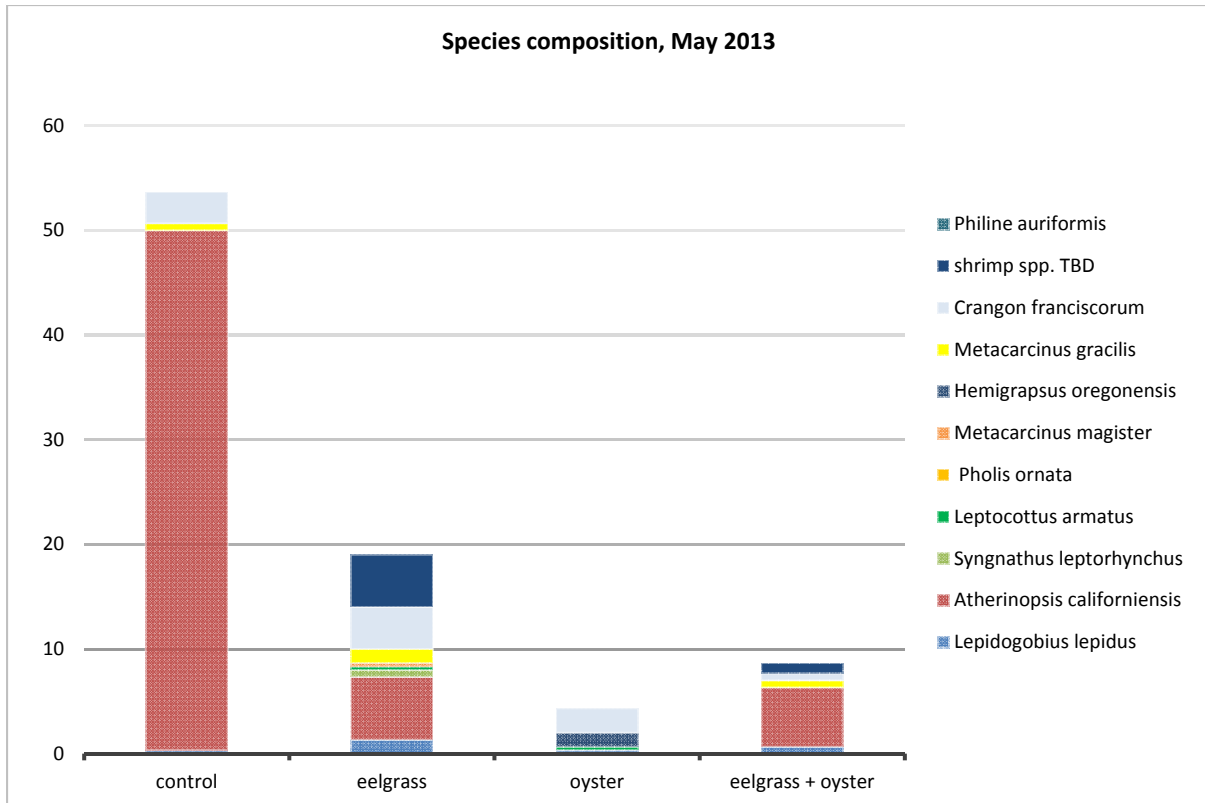
Figure B-14 – Mean number of individuals caught per 30m seine sweep in each treatment at The Nature Conservancy site in San Rafael, in May 2013. Contributions made by different species to the mean seine count are indicated by different colours.

The mean number of fish and invertebrates caught, and the contributions each species made to that mean count per 30m-seine transect, per treatment is shown for May 2013 in Figure B-14. The control area at the TNC site caught the highest number of individuals (mean = 53.67 per 30m seine) in May 2013, but had the lowest diversity (3 species), with *Atherinopsis californiensis* (Jacksmelt) contributing the most to this mean count (49.67 mean individuals). The highest diversity (and second highest mean count per seine = 19) was observed in the eelgrass treatment, with 8 species (mean of 6 individuals). The next highest mean count was observed in the eelgrass + oyster treatment (mean of 8.67 individuals, 5 species). The lowest mean count per seine was seen in the oyster only treatment (4.33 individuals, 4 species). The Jacksmelt contributed the most to the mean seine count in the eelgrass and eelgrass+oyster treatments, but was not seen in the oyster treatment where the most commonly caught individual was the Bay shrimp (*Crangon franciscorum*).

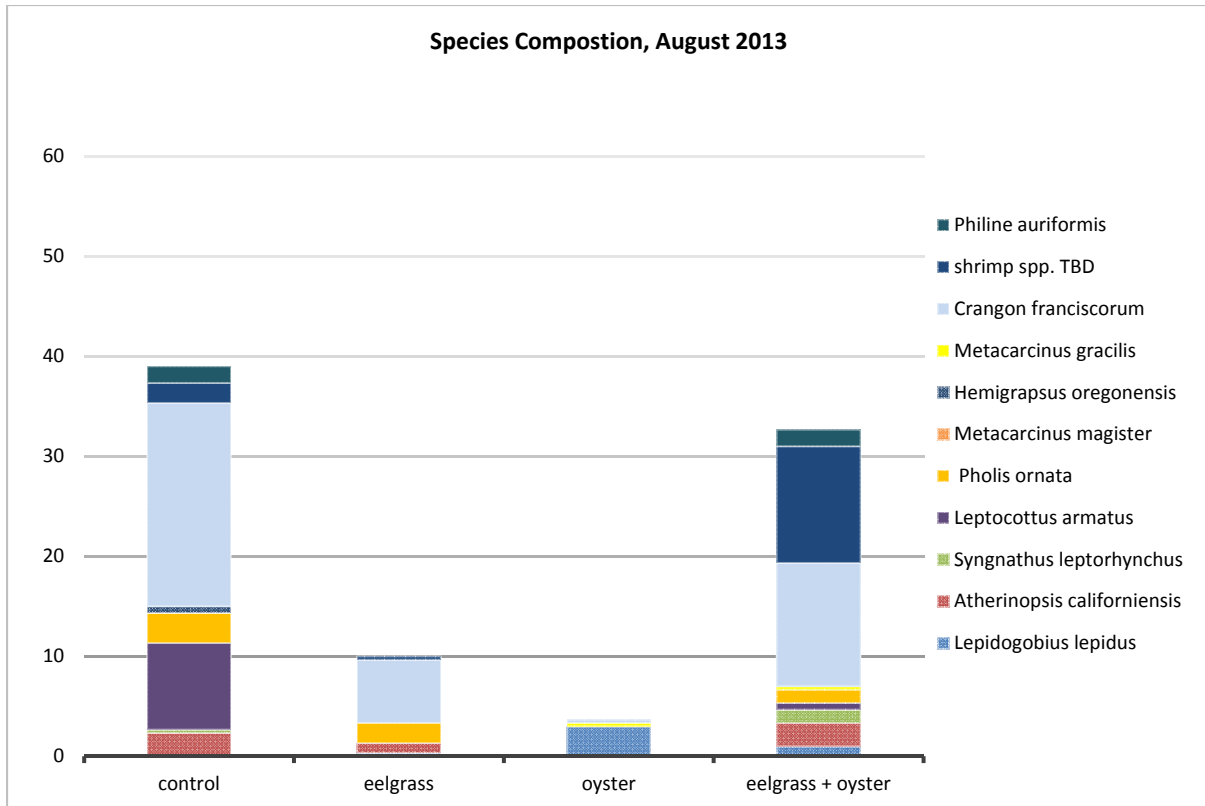
Figure B-15 - Mean number of individuals caught per 30m seine sweep in each treatment at The Nature Conservancy site in San Rafael, in August 2013. Contributions made by different species to the mean seine count are indicated by different colours.

In August 2013, the control area caught the highest number of individuals again (mean = 39.00 per 30m seine), with *Leptocottus armatus* (Pacific Staghorn Sculpin) contributing the most to this mean count (8.67 mean individuals) and 8 species observed in total (Figure B-15). The second highest mean count per seine was observed in the eelgrass and oyster combined treatment (mean of 32.67 individuals), and a slightly higher number of species caught (9 species) than the control. The most commonly seen species in this treatment was the Bay shrimp again (*Crangon franciscorum*, mean = 12.33). The next highest mean count was observed in the eelgrass treatment (mean = 10 individuals), with 5 species observed (less than May 2013) and the most commonly seen species being the Bay shrimp again (mean = 6.33). The lowest mean count per seine and diversity, as with the May 2013 seine results, was seen in the oyster only treatment (3.67 individuals, 3 species). The Bay Goby, (*Lepidogobius lepidus*) contributed the most to the mean seine count in this treatment (mean = 3).

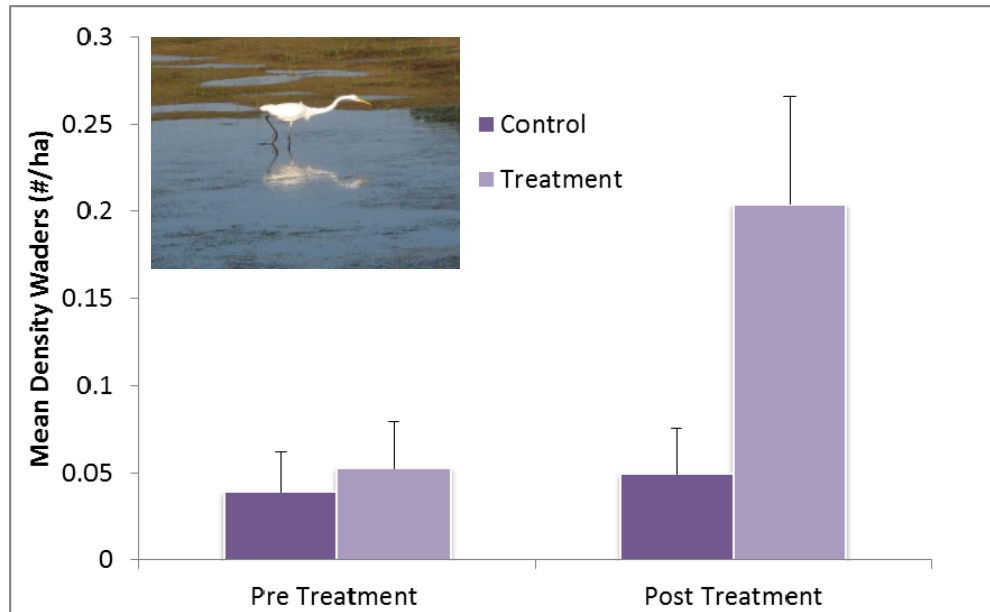
Figure C-4. Mean pre- (2011-2012) and post-installation (2012-2013) wader densities during low tide surveys in control and treatment plots for at ELN.

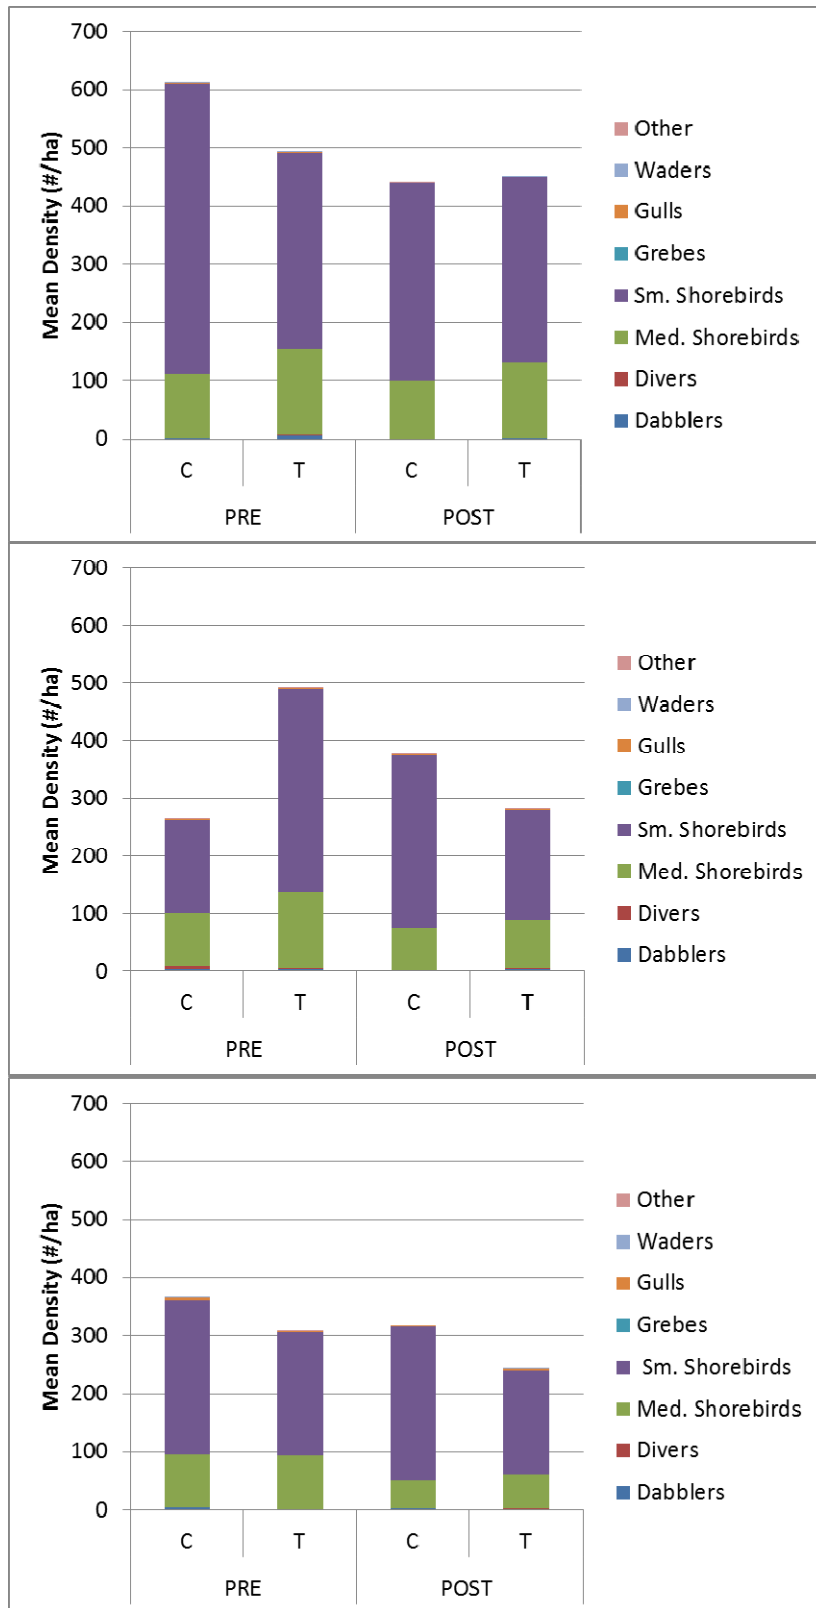
Figure C-5. Mean pre- (2011-2012) and post-installation (2012-2013) avian guild densities during low tide surveys in control and treatment plots for zones A, B, and C (top to bottom) at ELS.

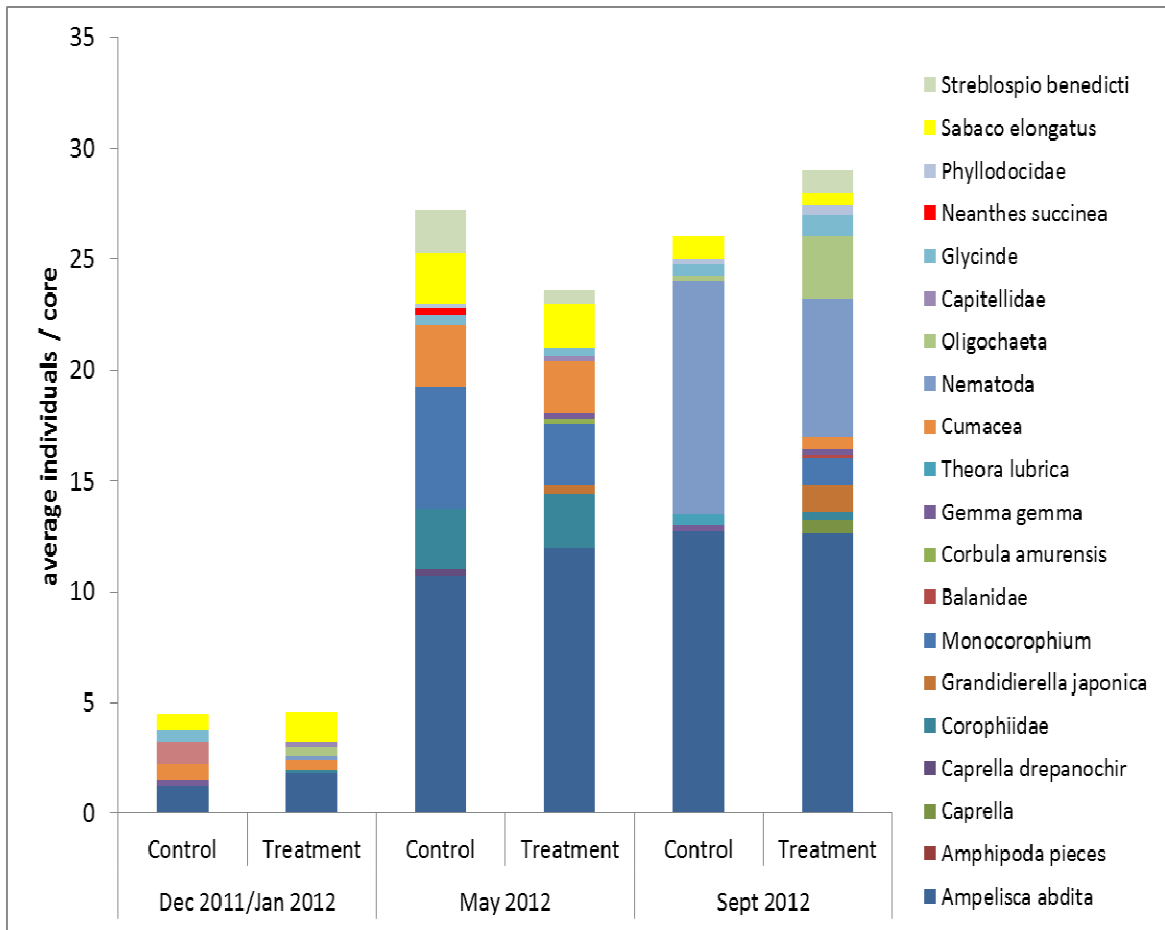
Figure C-6. Mean pre (Dec2011/Jan2012 and May 2012) and post-installation (2012-2013) number of invertebrate individuals found in zone B cores only at TNC.

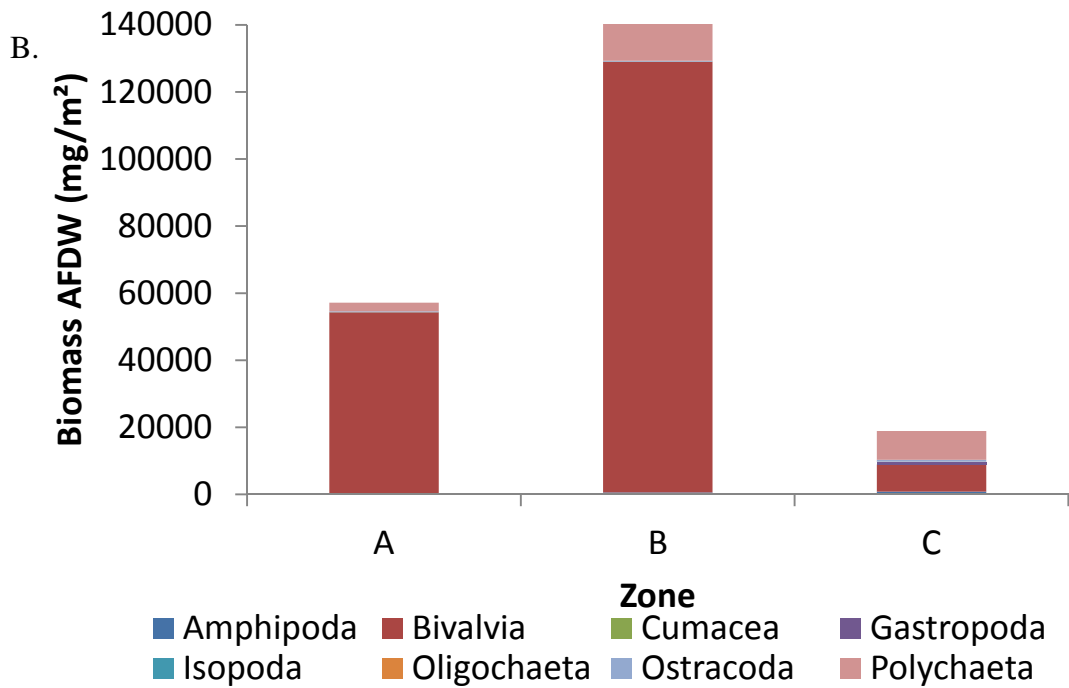
Figure C-11. Invertebrate biomass (AFDM mg m⁻²) by taxa at paired control (A) and treatment (B) areas at ELN in Sept 2012.

Benthic Invertebrates -- Preliminary data summaries suggest the average number of individuals in TNC treatment zone B cores remained similar between pre (May 2012) and post (Sept 2012) installation periods; however the number of taxa in treatment zone B increased (Fig. C-6). Polychaetes comprised over 90% of the biomass found in post-restoration (Sept 2012) TNC cores, except bivalves predominated in control zone C (Figs C-7 & C-8). In contrast, bivalves, notably *Gemma gemma*, were found in highest densities both pre and post-restoration at ELN, with post-restoration *Gemma gemma* densities more than 2-times greater than pre-restoration cores from treatment zone B (Fig. C-9). *Gemma gemma* also dominated macroinvertebrate biomass at ELN, which was highest in treatment zone B where test elements were installed (Figs C-10 & C-11).

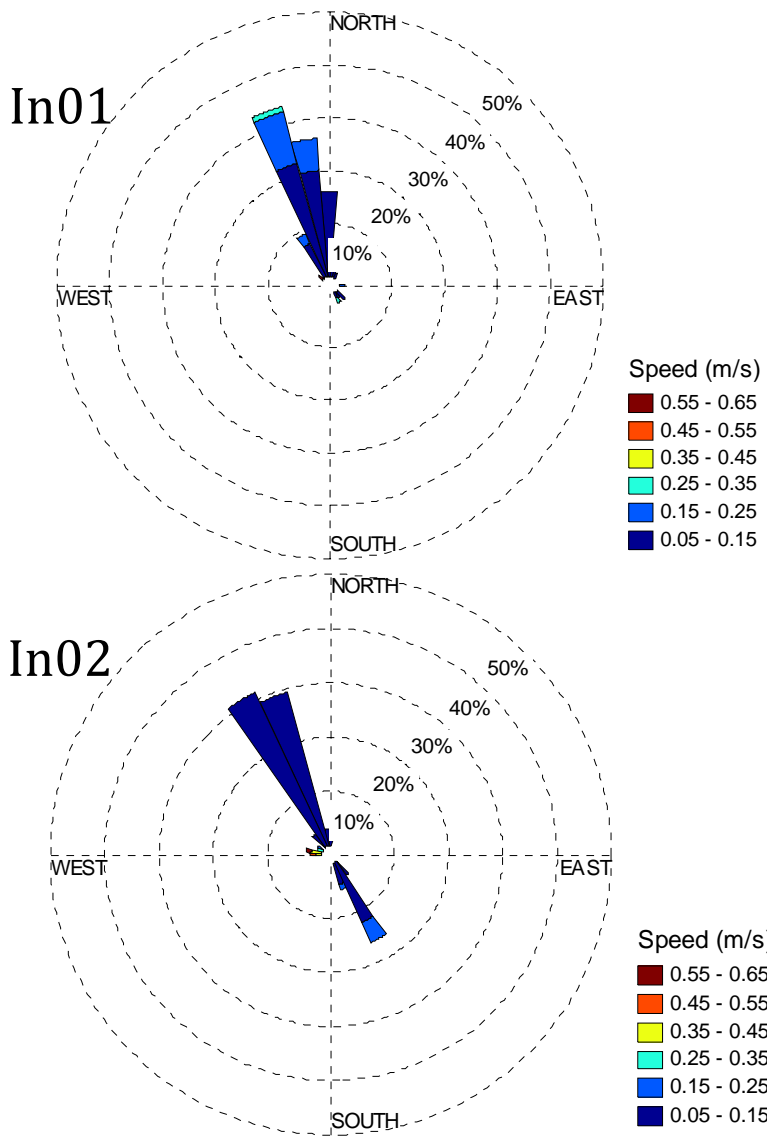
Figure D-6: Current data collected by the ADCP for the two inshore instruments at the San Rafael site from February 26-April 16, 2013 with In1 behind the oyster-eelgrass reef and In2 at the control plot. Currents behind the reef (In1) were observed to be faster in general but flood only. This contrasts with the current data for the control plot (In2) that shows a symmetrical distribution from NW-SE at slower speeds than at In1.

Wave height and wave period show different patterns for the two locations with fewer observations gathered for the instrument in the lee of the oyster-eelgrass plot than the one at the control plot. Wave heights ranged 6- 26 cm for both with a unimodal distribution at the control plot compared to a bimodal distribution for the one in the lee of the reef (Figure D-5). Differences were also seen in the currents in the lee of the reef. Velocities were observed to be faster and flood-dominated, with negligible ebb tide velocities. This contrasts with the current data for the control plot that shows a symmetrical distribution for the flood and ebb tides (NW-SE angle) but at slower speeds (Figure D-6).

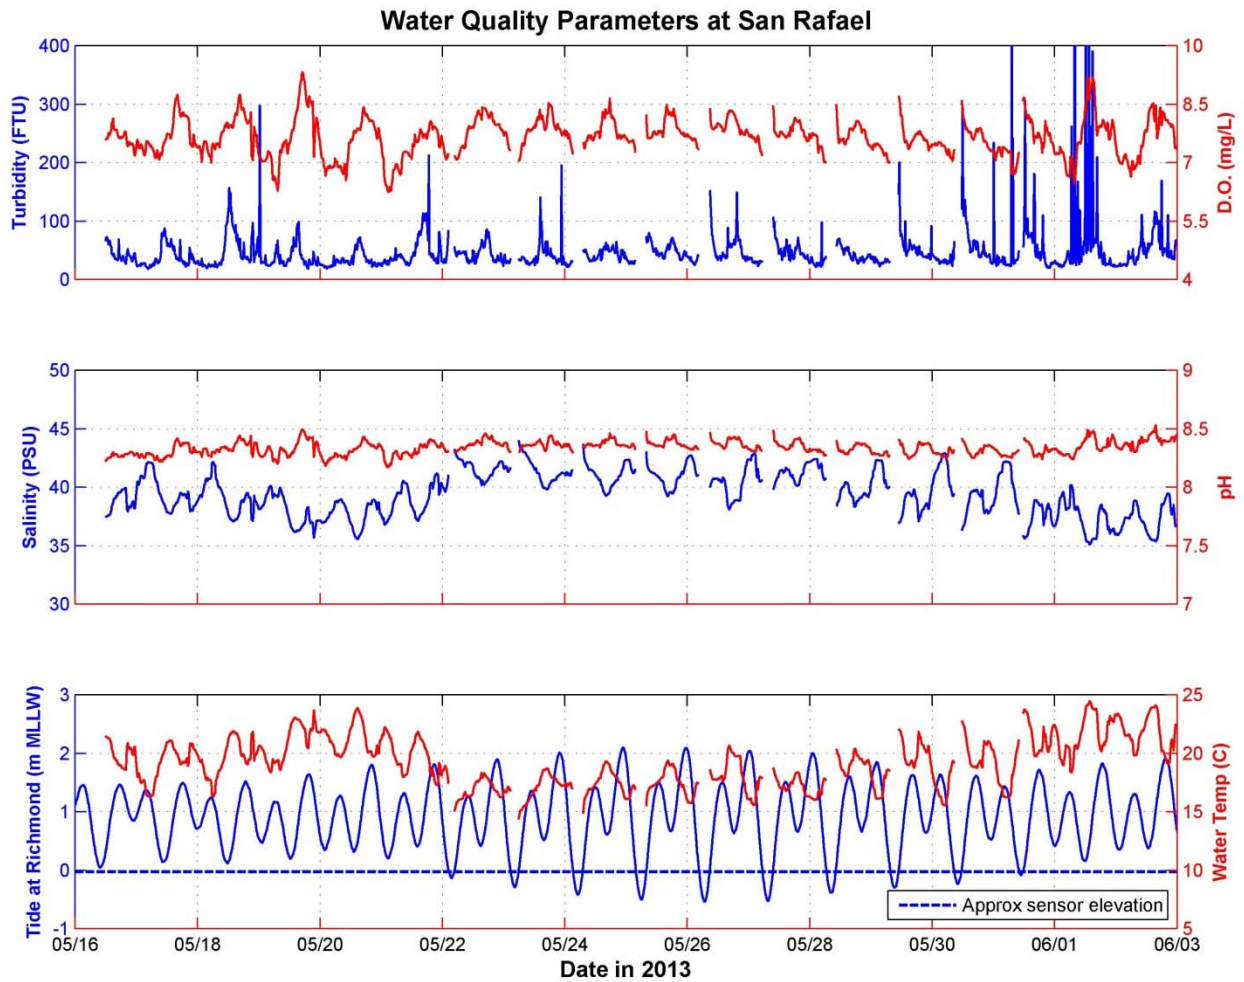
Figure D-7: Ambient water quality data for the San Rafael site from May 16-June 3, 2013. Breaks in the record indicate when the instrument was exposed during low tide (blue line in bottom panel). Some parameters are fairly conservative and do not vary substantially (pH, dissolved oxygen) while others track with tide or wind events (temperature, turbidity). A problem with the salinity sensor skewed the results above what is normal for the San Francisco Bay.

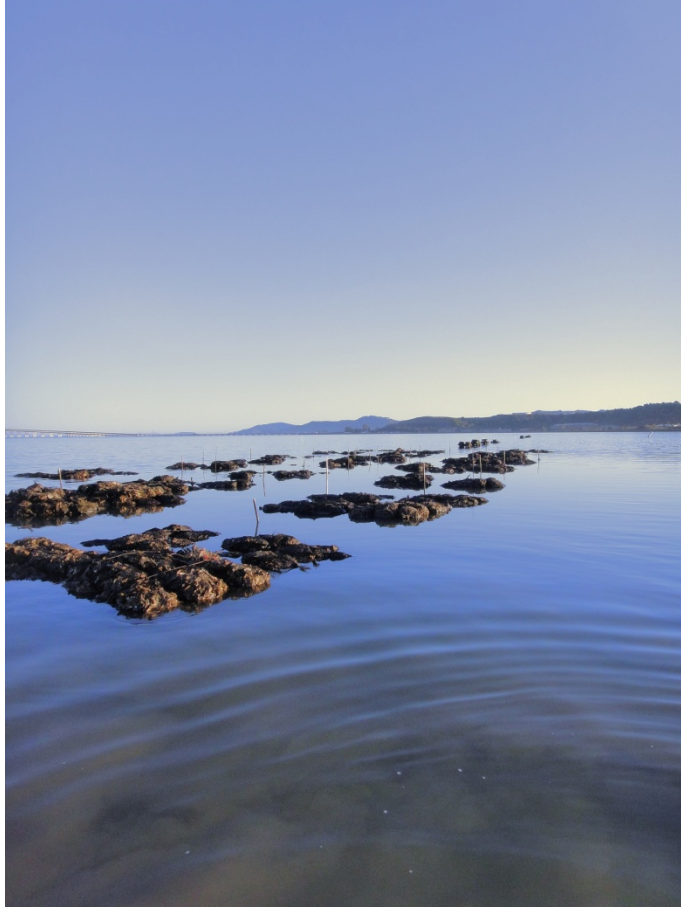
San Rafael site- Pacific shell bag mounds

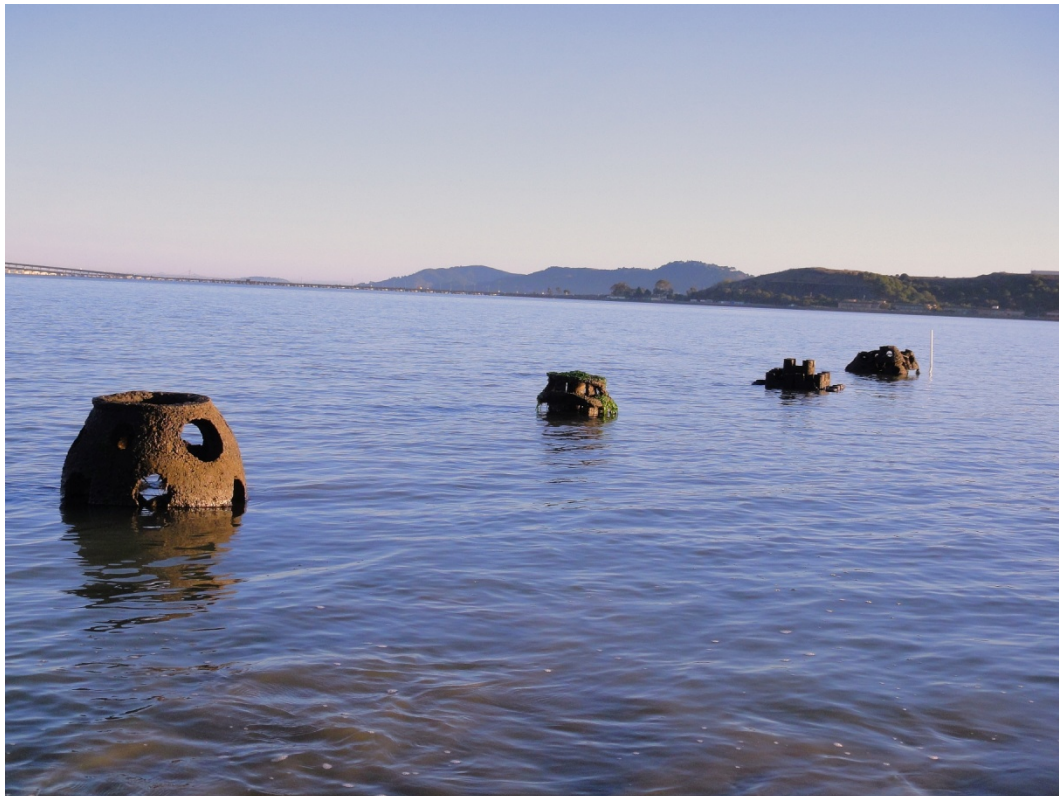
San Rafael site- "baycrete" elements

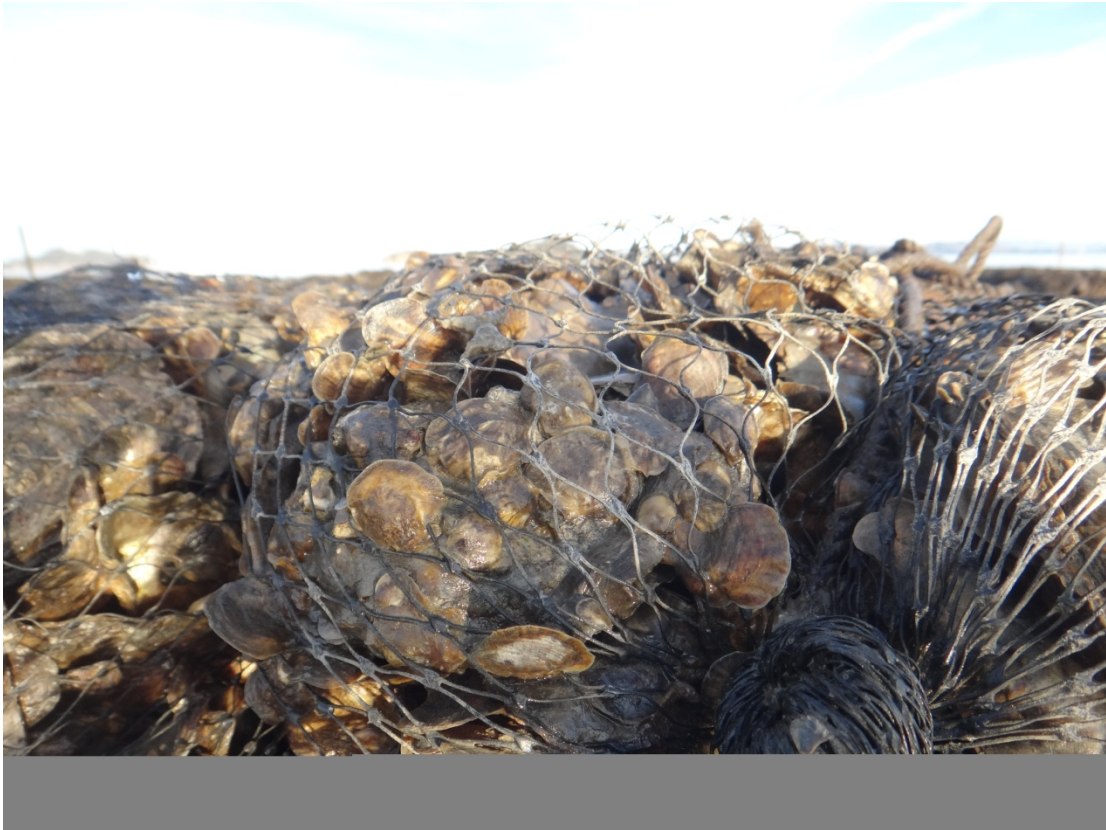
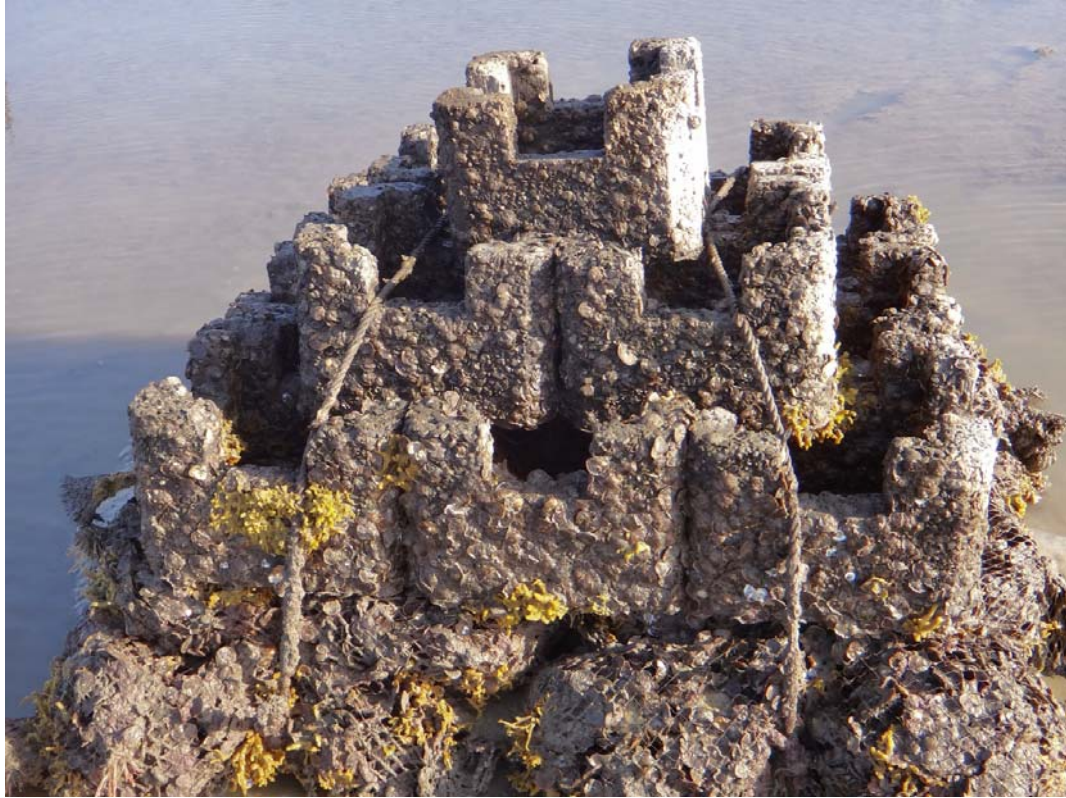
San Rafael site- native oysters settled on “baycrete” elements- oyster blocks (top picture) and mini reef ball stacks (bottom picture).

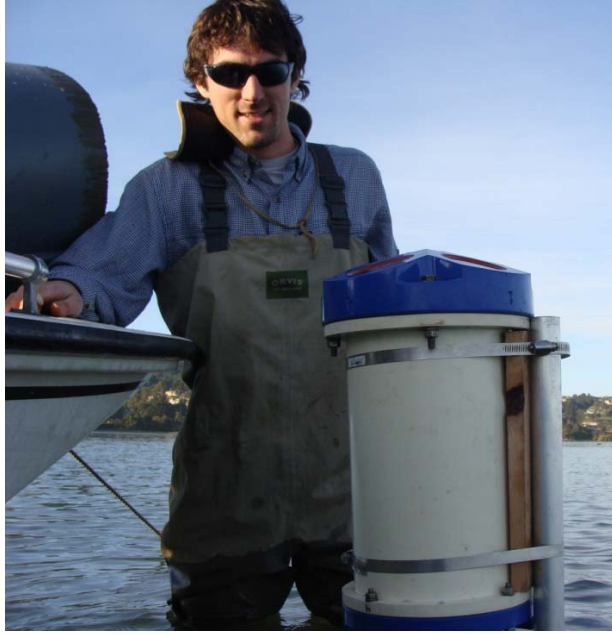
Acoustic Doppler Current Profiler (ADCP) deployment inshore of oyster-eelgrass plot. In picture, Eddie Divita of ESA PWA.

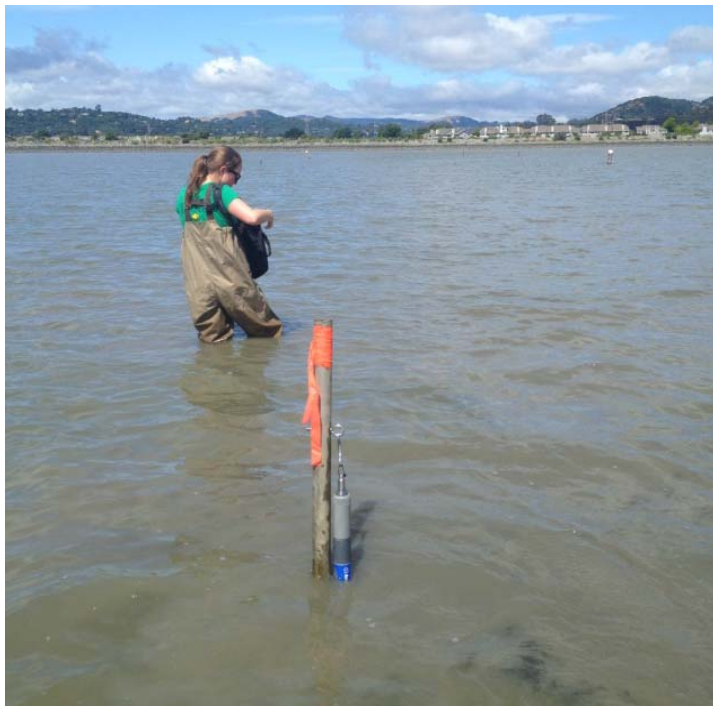
Installation of ambient water properties instrument, a Nortek Sonde to measure temperature, salinity, pH, dissolved oxygen and turbidity. The Sonde is mounted on the stake in the foreground. In picture, Elena Vandebroek of ESA PWA.

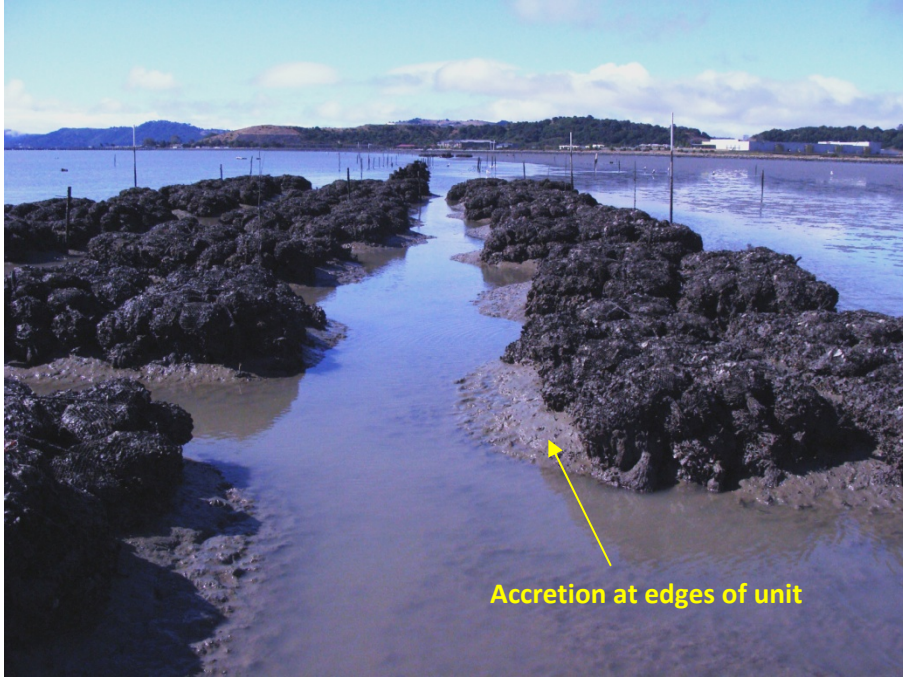
Oyster-Only plot at San Rafael, facing south, looking at the sediment accretion patterns along the edges of the units. Note sediment accretion in the lee of the units. Elevation surveys of the bed were gathered immediately adjacent to the units and then down the centerline of the aisles to determine sediment volume changes.

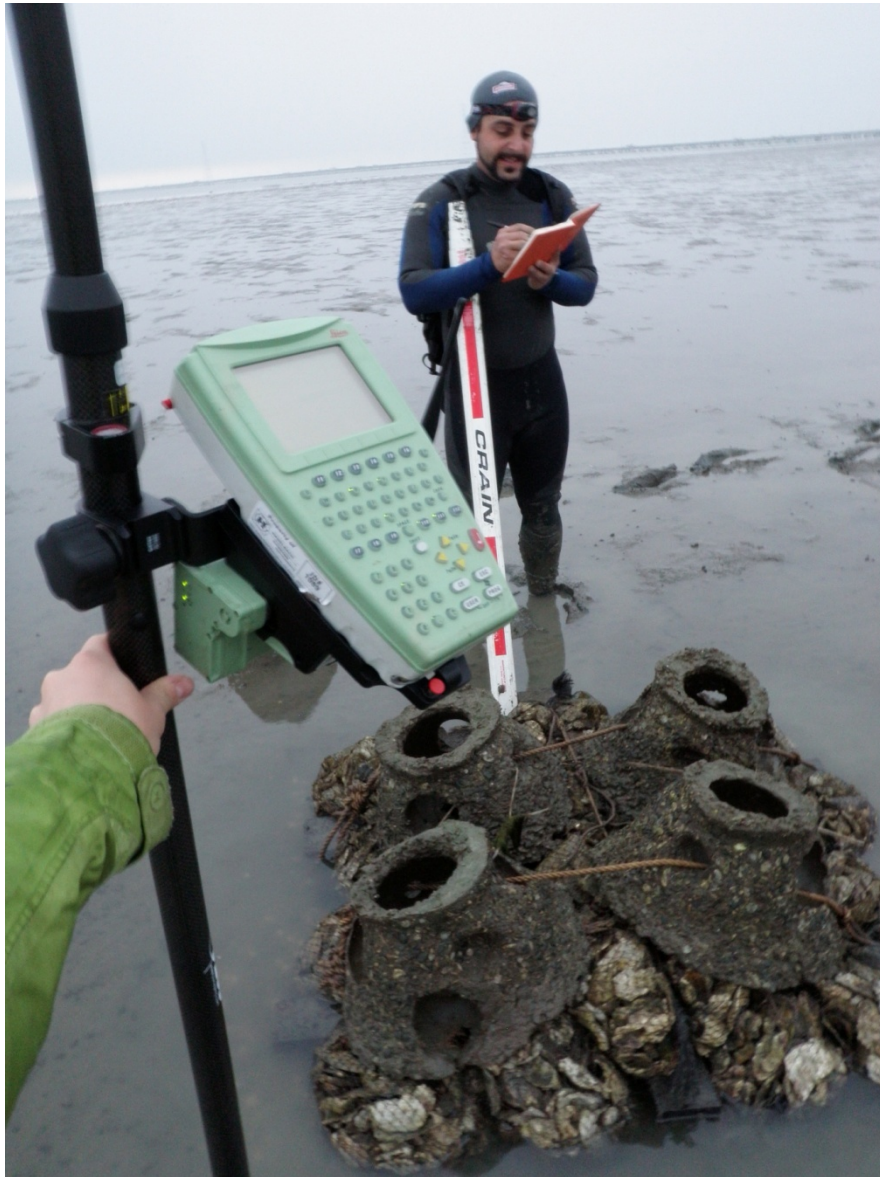
ESA PWA oceanographer Doug George and coastal engineering Elena Vandebroek surveying the elements on Eden Landing and measuring sediment accumulation.

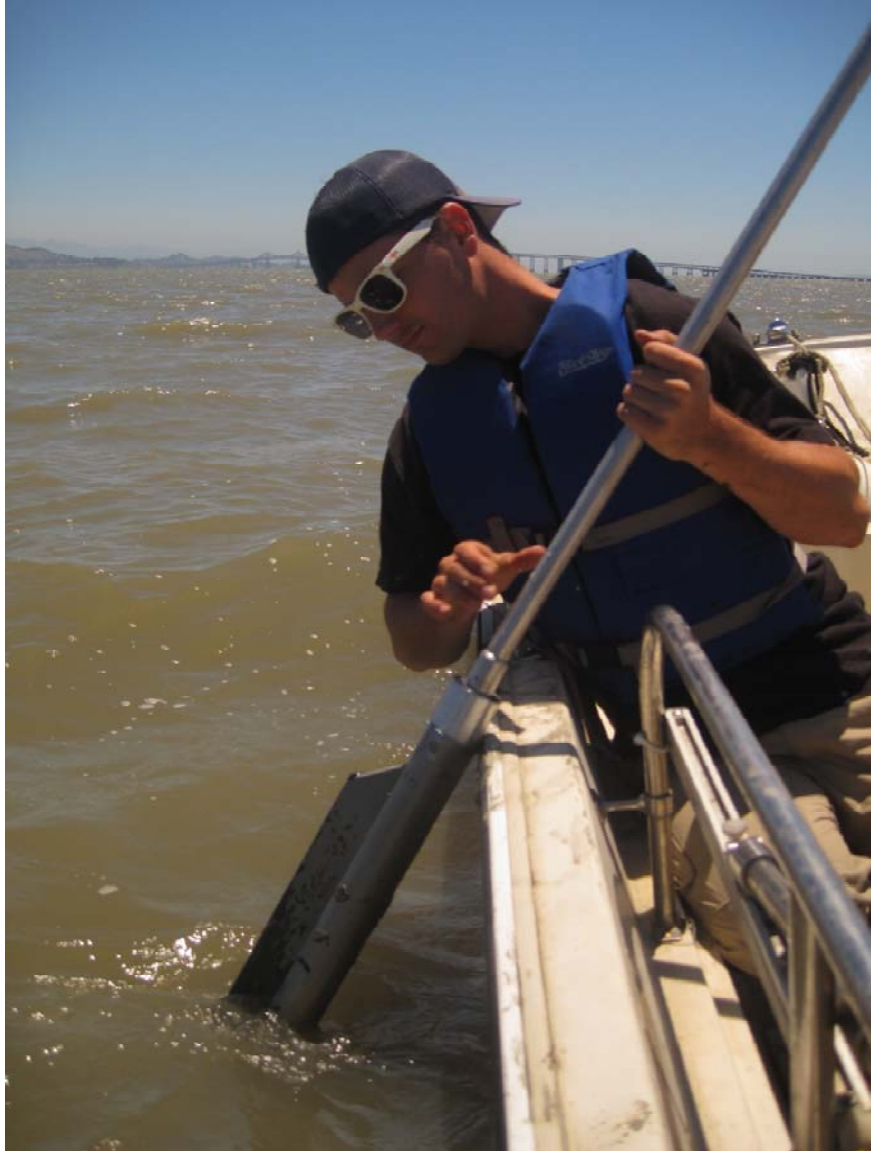
ESA PWA field services manager Damien Kunz collecting sediment cores at the San Rafael site prior to construction of reefs to establish baseline sediment grain size distribution.
